RED LODGE
COMMERCIAL HISTORIC DISTRICT
REVITALIZATION
MASTER PLAN

1986

Carbon County, Historic Preservation Office • Red Lodge, Montana
Michels Raffety Architects • Livingston, Montana

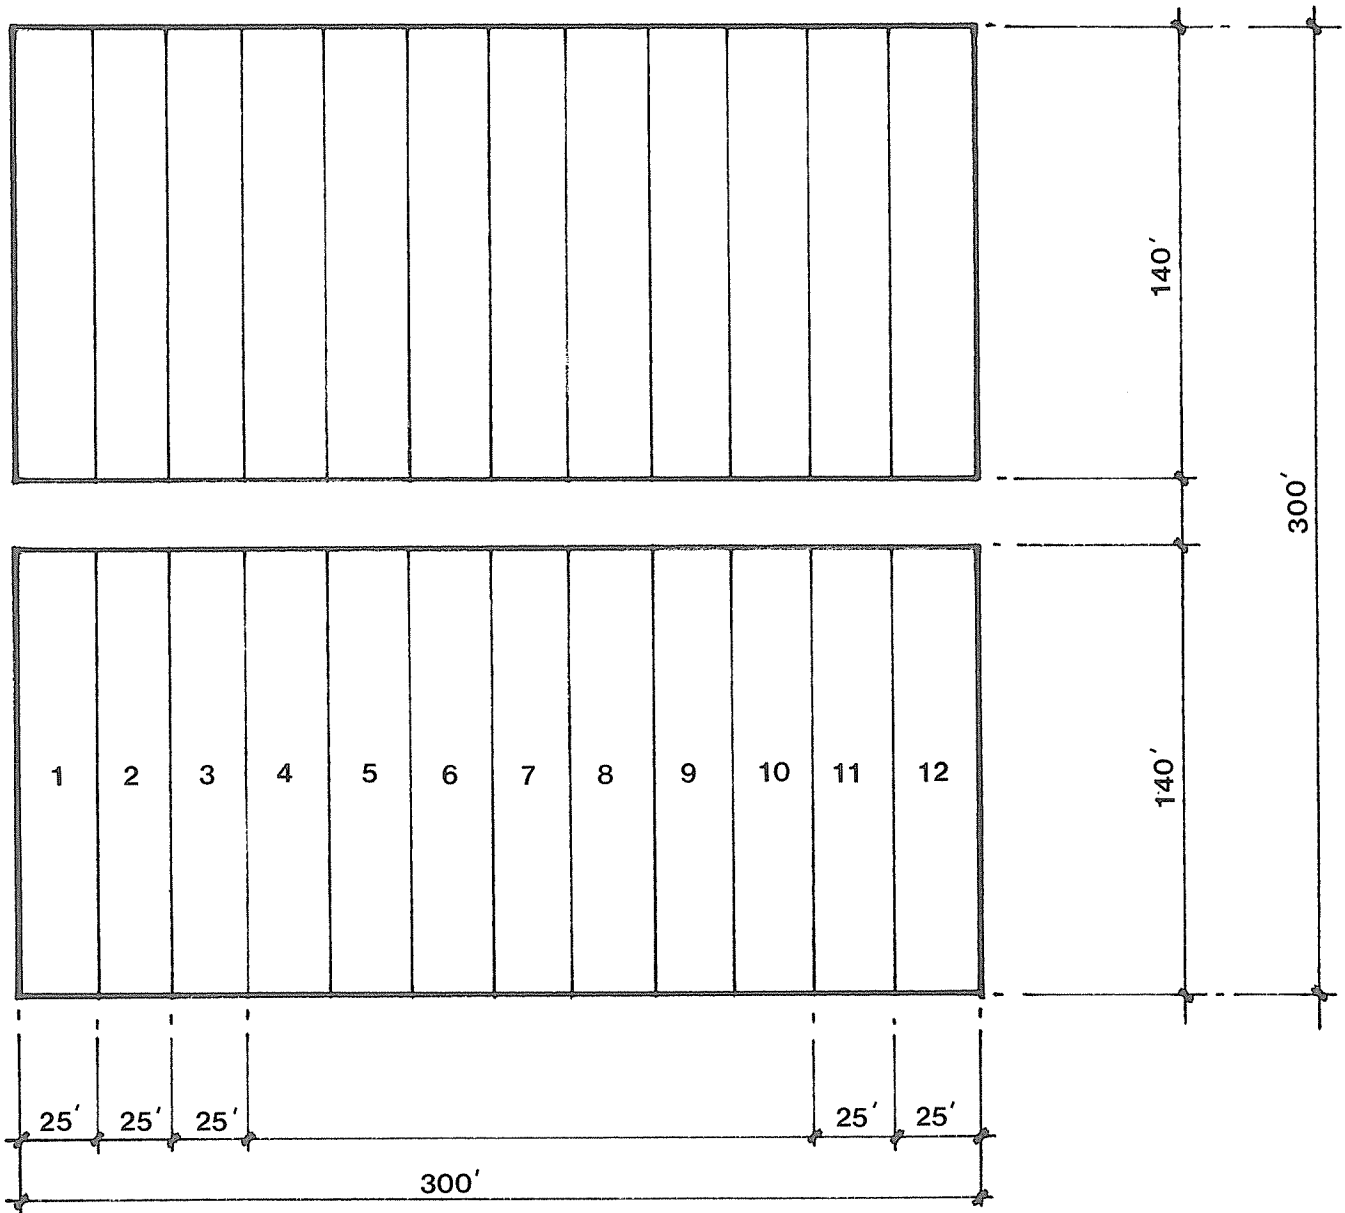
Fig. 2. Original platting of commercial block showing typical lot layout.

Owners who had businesses requiring additional street frontage purchased adjacent lots or portions of lots to meet their needs. Buildings such as hotels, theatres, meeting halls, and public buildings typically required greater street frontage, and more than a single lot.

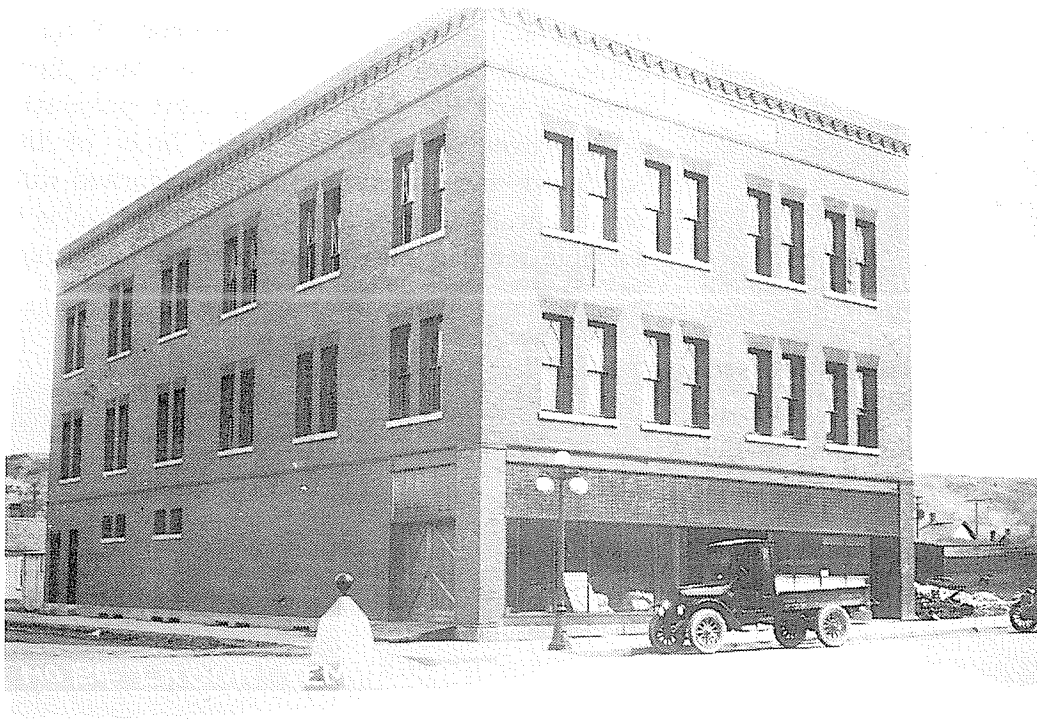
Fig. 5. Excellent example of a 1920s-1930s metal mullion and leaded glass transom storefront.

glass transoms were better suited for use in storefronts wider than 25', where the transom could develop a pleasing horizontal proportion. Even in narrower versions, however, the transparent leaded glass panels related to the plate glass storefront windows, thus continuing original glazing proportions. Examples of proposals for rehabilitation of various storefront transoms may be found in the Block-by-Block section.

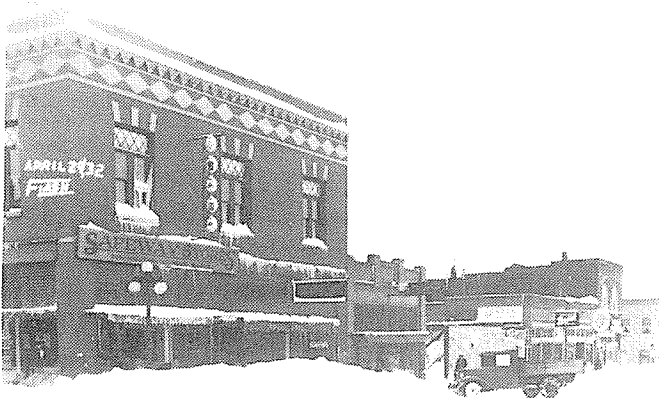
Fig. 6. Note polychrome brick patterns and leaded glass transom.

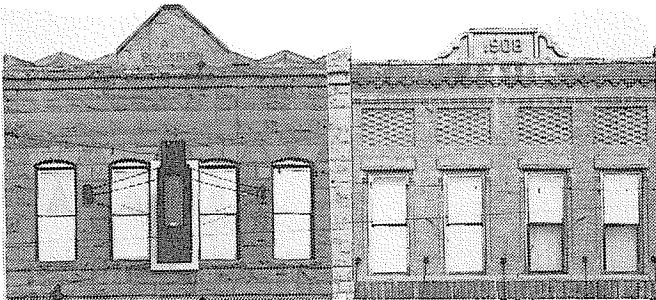
The top element of the facade, the cornice, terminates the composition. Cornices were constructed of various materials and in a variety of styles. Masonry buildings often had a parapet wall made of brick. Cornice brickwork typically exhibited the most ornamental pattern. Often the cornice was accentuated with small projections that were ideal locations for placing a stone carved with the building's construction date or owner's name.

Fig. 7. Name and date stones above cornice add interest and sense of past to building.

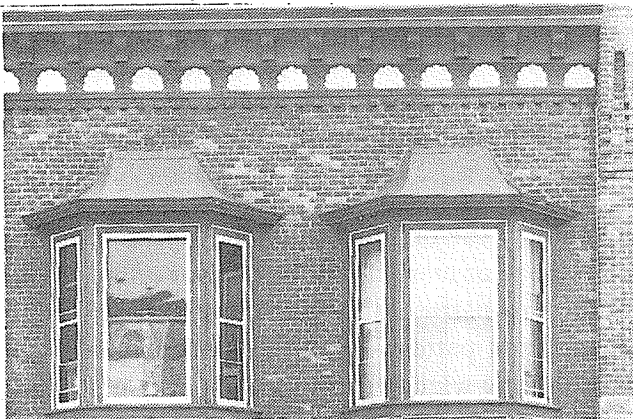
Another common cornice material was pressed sheet metal. These metal cornices were made to look like fancy cut stone, as can be seen on the A.J. Davis Jewelry Store (The Mountain Shop) at 16 N. Broadway.

Fig. 8. Original sheet metal cornice imitates sculpted stone ornament.

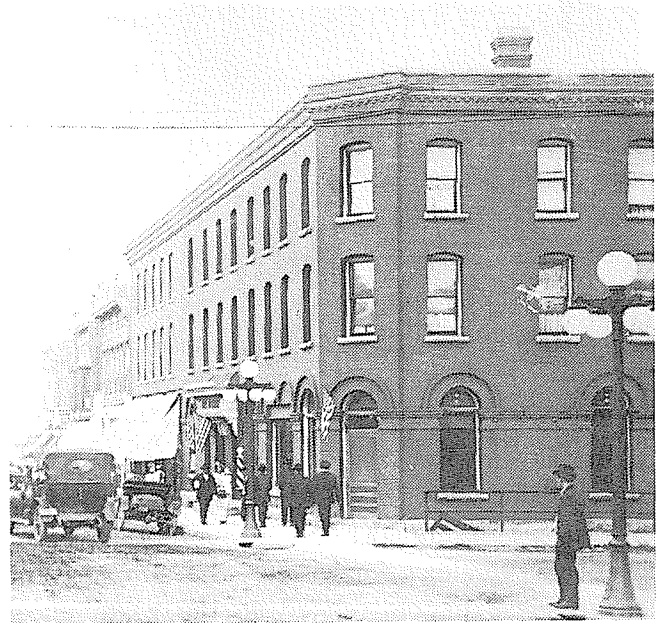
The tripartite scheme applies not only to 25 foot store fronts, but to larger buildings as well. For instance, hotels such as the Spofford Hotel (currently the Pollard) also follow the basic

tripartite pattern of base, body, and cornice. The base is accentuated with a continuous Romanesque arch brick motif above the first floor windows and the addition of a short projecting canopy over the entryway. The body of the building is two stories, basically unadorned with symmetrically placed windows, and the cornice is a simple dentilated brick pattern with a metal cap.

Fig. 9. Tripartite pattern used for Spofford Hotel [ca. 1920].

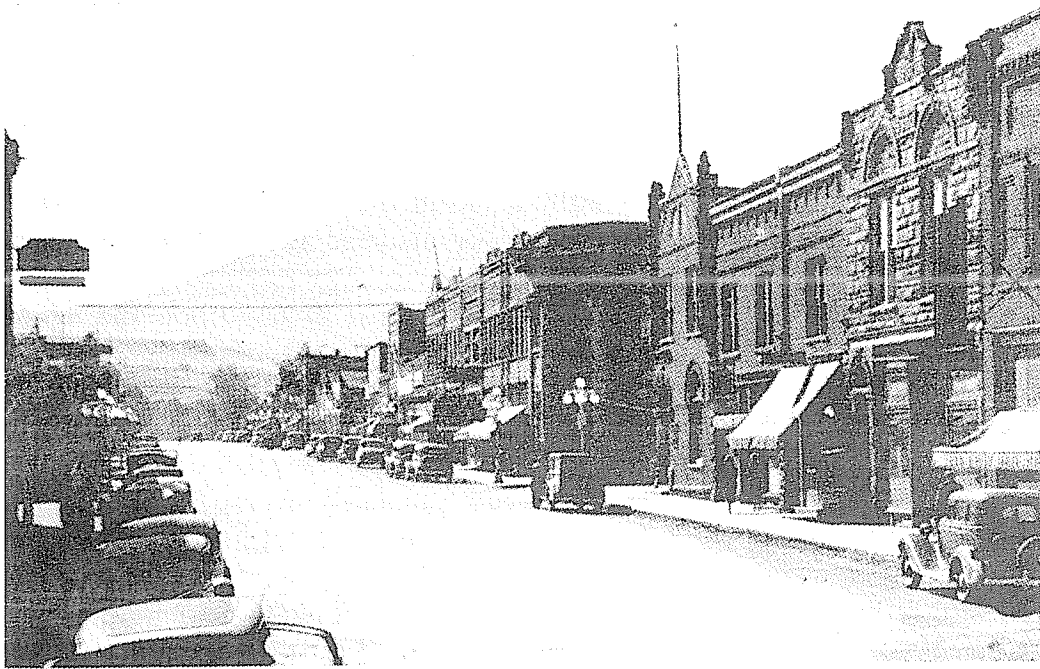
Business Section, Red Lodge, Montana

Fig. 12. Early 1900s. Compare upper facades and cornices with current photo below. Note simplicity of signage.

streetscape of Red Lodge, its historic character can still be sensed. Most second-story facades appear as they did when they were built. Compare and note the high degree of integrity still visible in the upper facades shown in Figures 12 and 13.

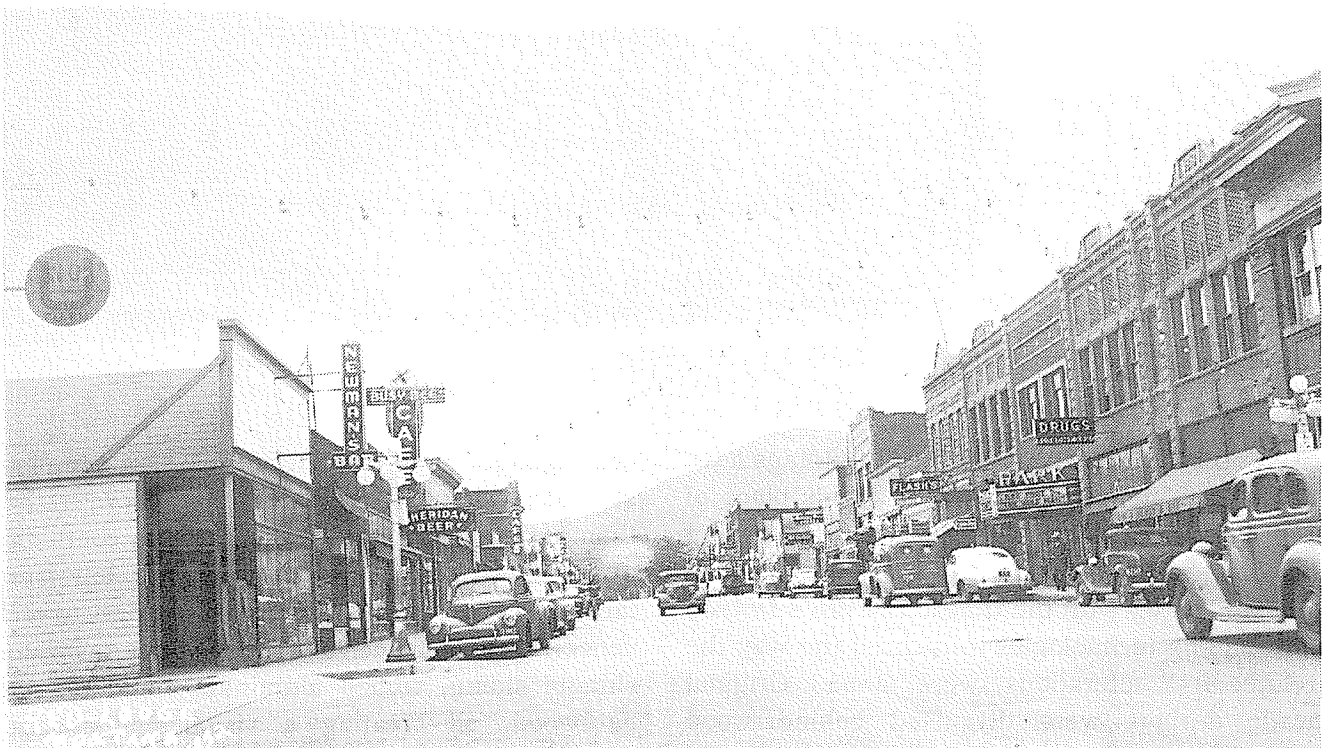
Figure 14. Broadway looking south [ca. 1940s]. Signs have continuity, facades still retain integrity.

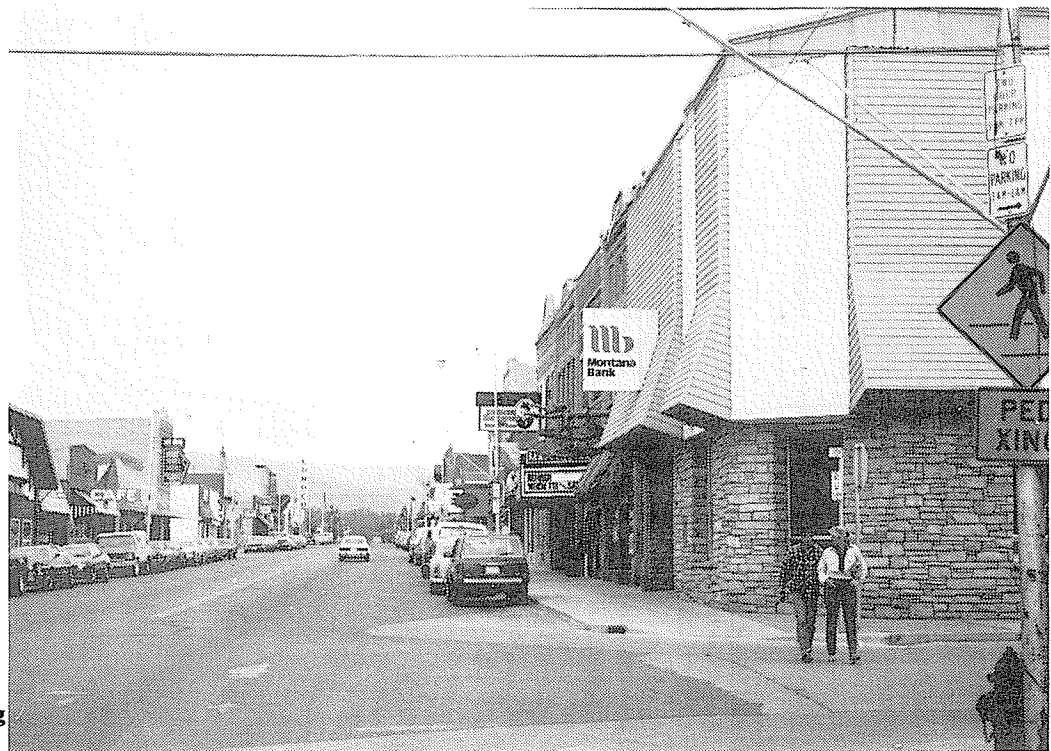
Fig. 15. Broadway looking south, 1986.

The 1986 photo shows the current condition of the streetscape. Here signage has progressed to colossal proportion and elevation on the facades. The sign can completely overpower the facade. With prefabricated and catalogue-order sign boards, the thread of continuity in size and style is gone. The historic street lights are gone, replaced in the 1950s by high mast pole lights that do not have the human scale as did historic street lights. A majority of the awnings are also missing. Lower facades and transom areas have not fared so well in the last four decades. The continuity of original composition of the downtown has given way to a

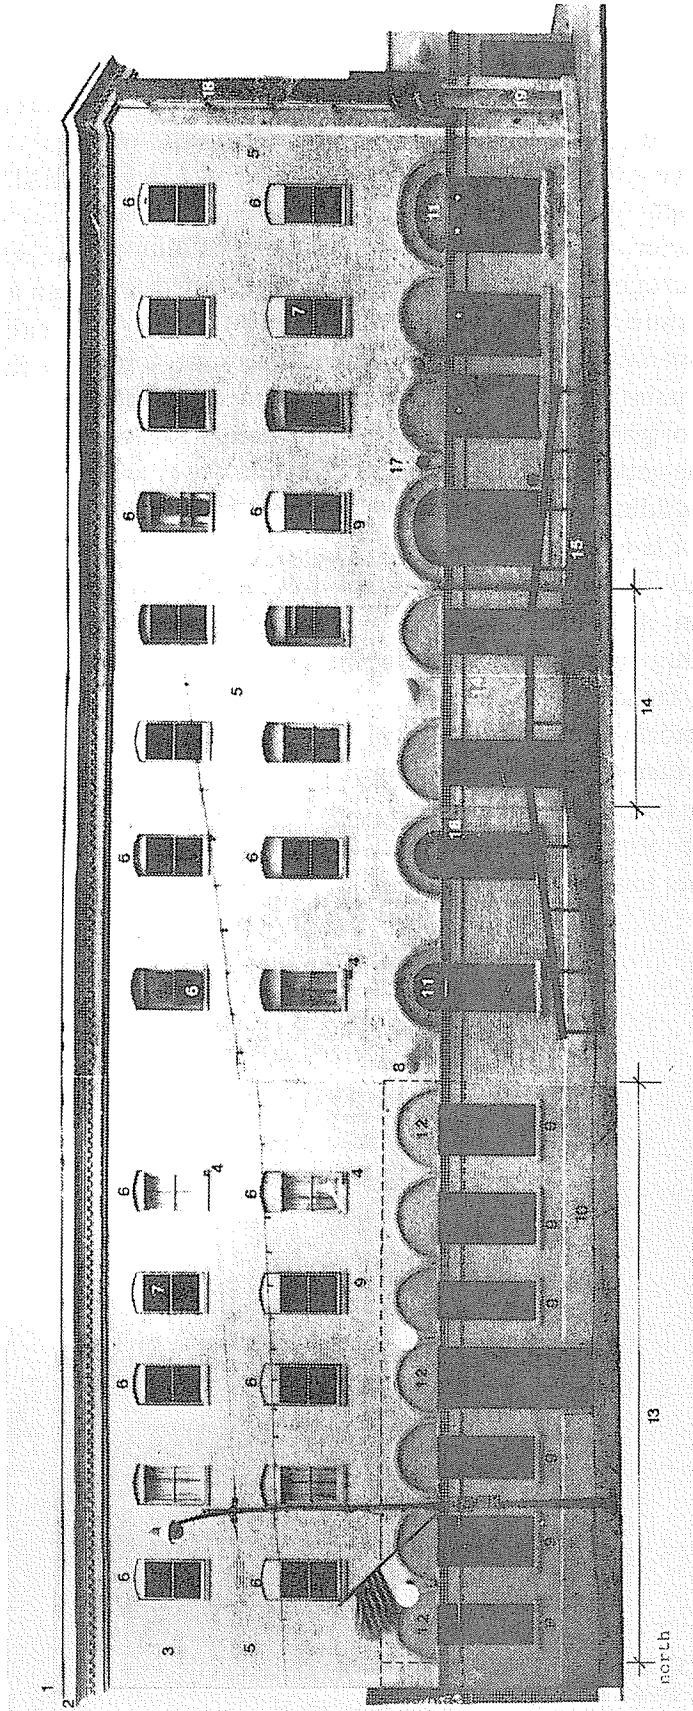
Block No. 30 Lot No. 11, 10, 9, 8, 7 Orig. Plat, Red Lodge, Mt.
 Street Address 2 North Broadway
 Historic Building Name Spofford Hotel
 Current Building Name Pollard Hotel
 Current Building Owner Virgil Braden

- 1. Etch, prime, paint new galvanized cornice cap, caulk as required
- 2. Prep and paint original metal shaped cornice
- 3. Repoint building as required (all)
- 4. Remove and replace all spalded brick as required, patch areas
- 5. Prep wall surface, paint (color cattails)
- 6. Remove and recess all infill panels, replace as required; min. 4" recess; 6" max.
- 7. Paint all windows and sash

Fig. 16. Existing condition analysis, Pollard Hotel

All buildings need maintenance. We conducted an analysis of each building to determine both the maintenance needs and the integrity of the historic features. These existing condition analyses were the initial tool used by the architects in the design decision-making process to determine an appropriate economic approach for the building rehabilitation. The following is an example of an existing condition analysis of the Spofford Hotel (Pollard Hotel).

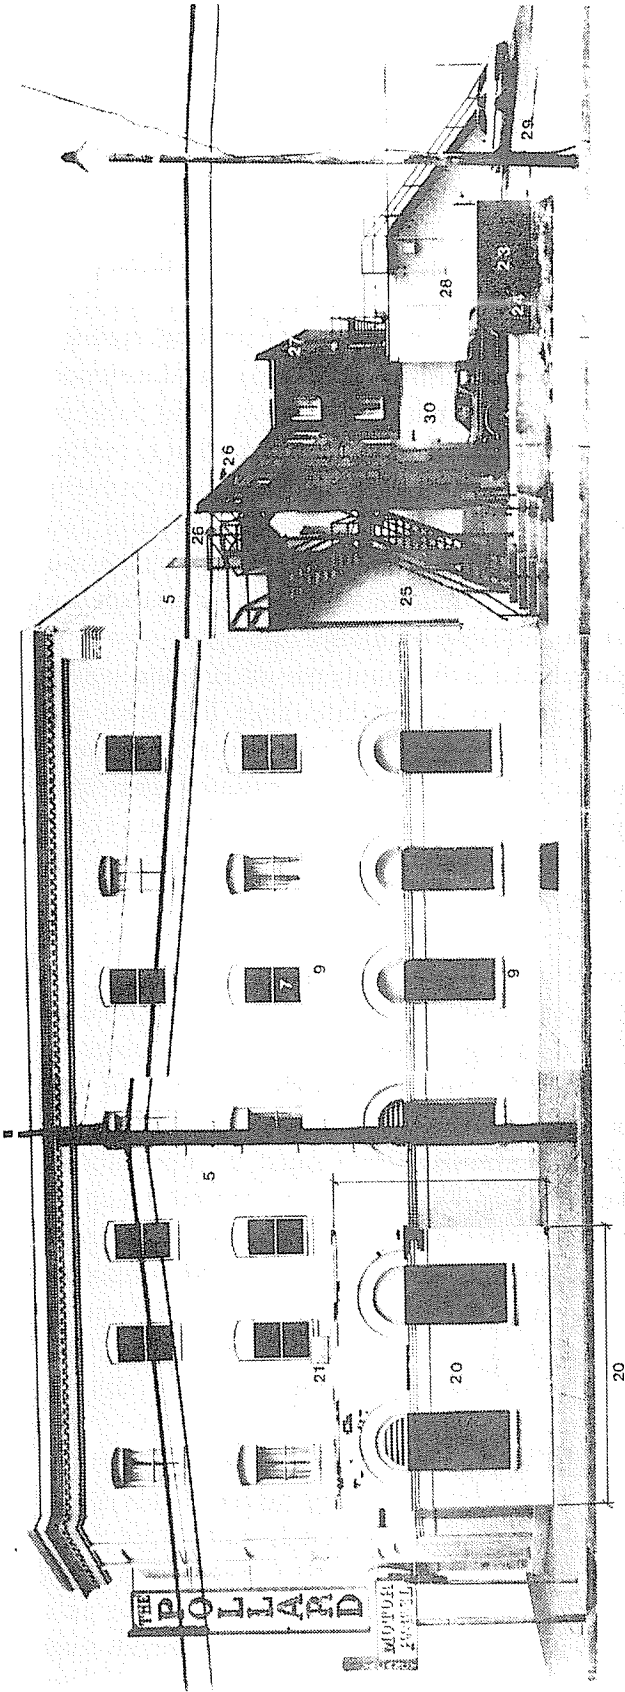
Block No. 30 Lot No. 11, 10, 9, 8, 7
 Street Address 2 North Broadway
 Page No. Two

24. Paint transformer box
 25. Paint stair (fire escape)
 26. Paint all steel doors
 27. Remove and replace parapet wall
 28. Paint block building
 29. Redetail parking area

30. Develop rear entrance/service to hotel-ciub-kitchen-bar

Fig. 17. Existing condition analysis, Pollard Hotel

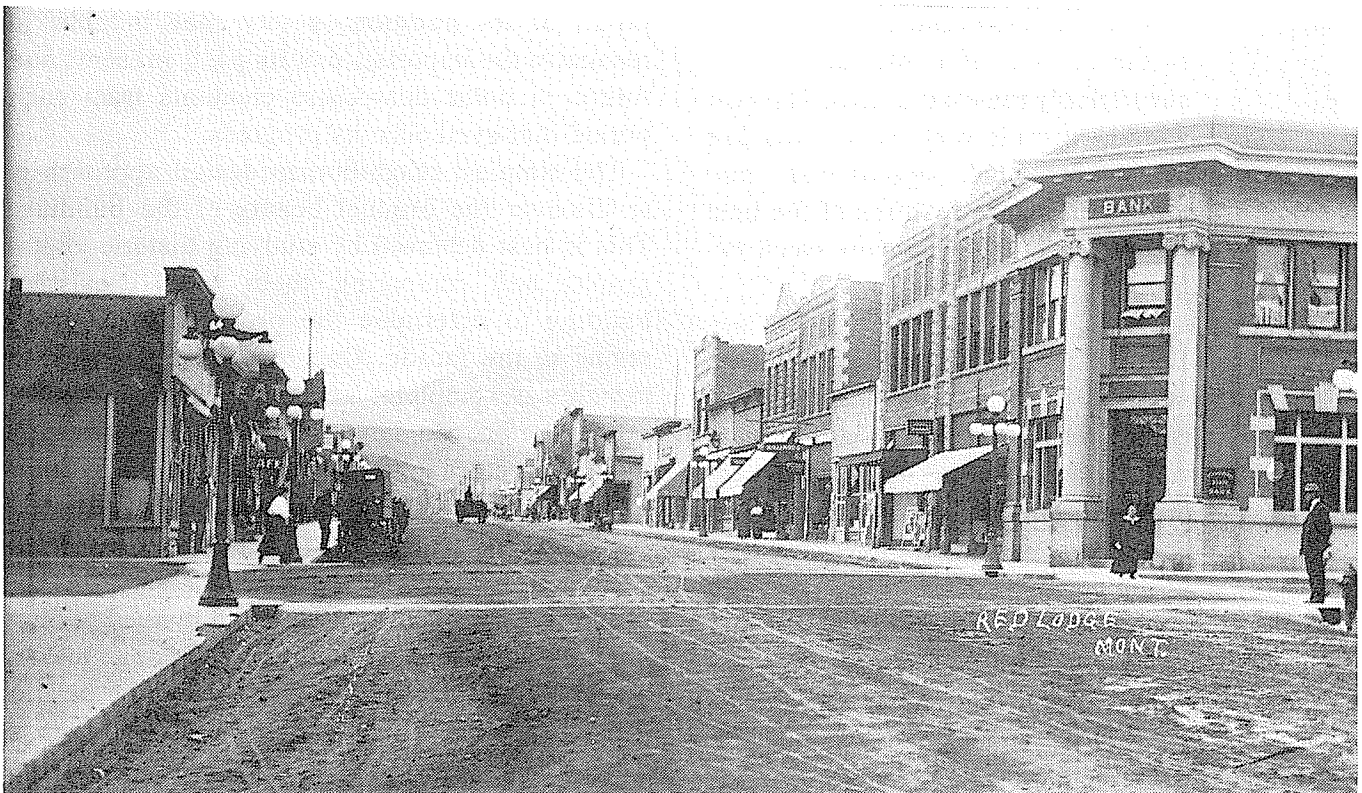
Fig. 18. The clean upper facades, historic streetlights, and low projecting awnings give a human scale to the streetscape and allow the buildings to be a prominent element.

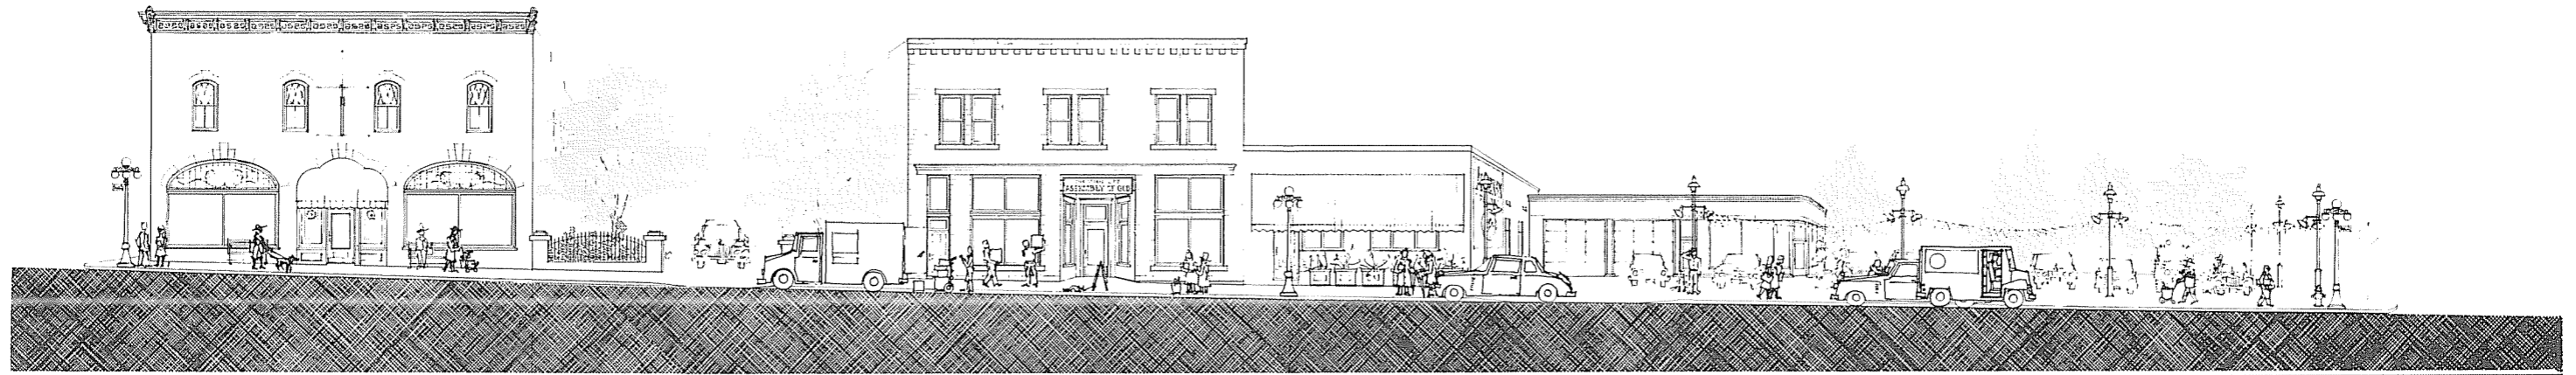
201 North Broadway
Olcott Funeral Chapel
Panel entry to imitate original. Replace storm window and doors. False front on carport at rear. Awning over entry. Historic colors. Projecting storage.

209 North Broadway
Christian Life Assembly of God
Restore facade. Historic colors, front and side walls. Replace entry door. Signage in entry recess.

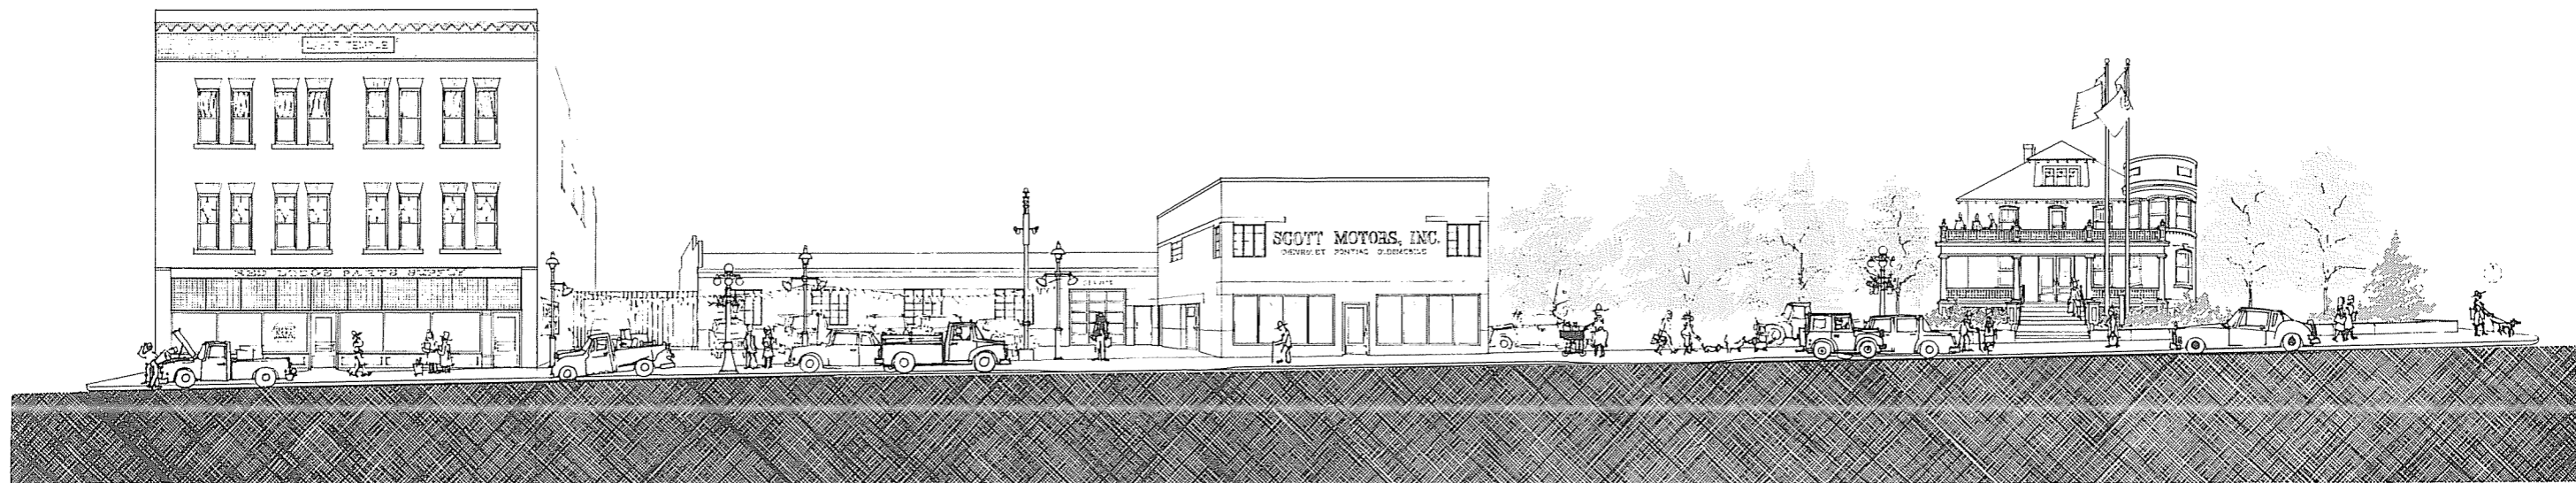
224 North Broadway
Red Lodge Parts Supply/
Labor Temple
Restore entire facade,
windows and entryways
Restore storefront
with transom. Historic
colors. Lintel and
window splay
South sidewalk signage

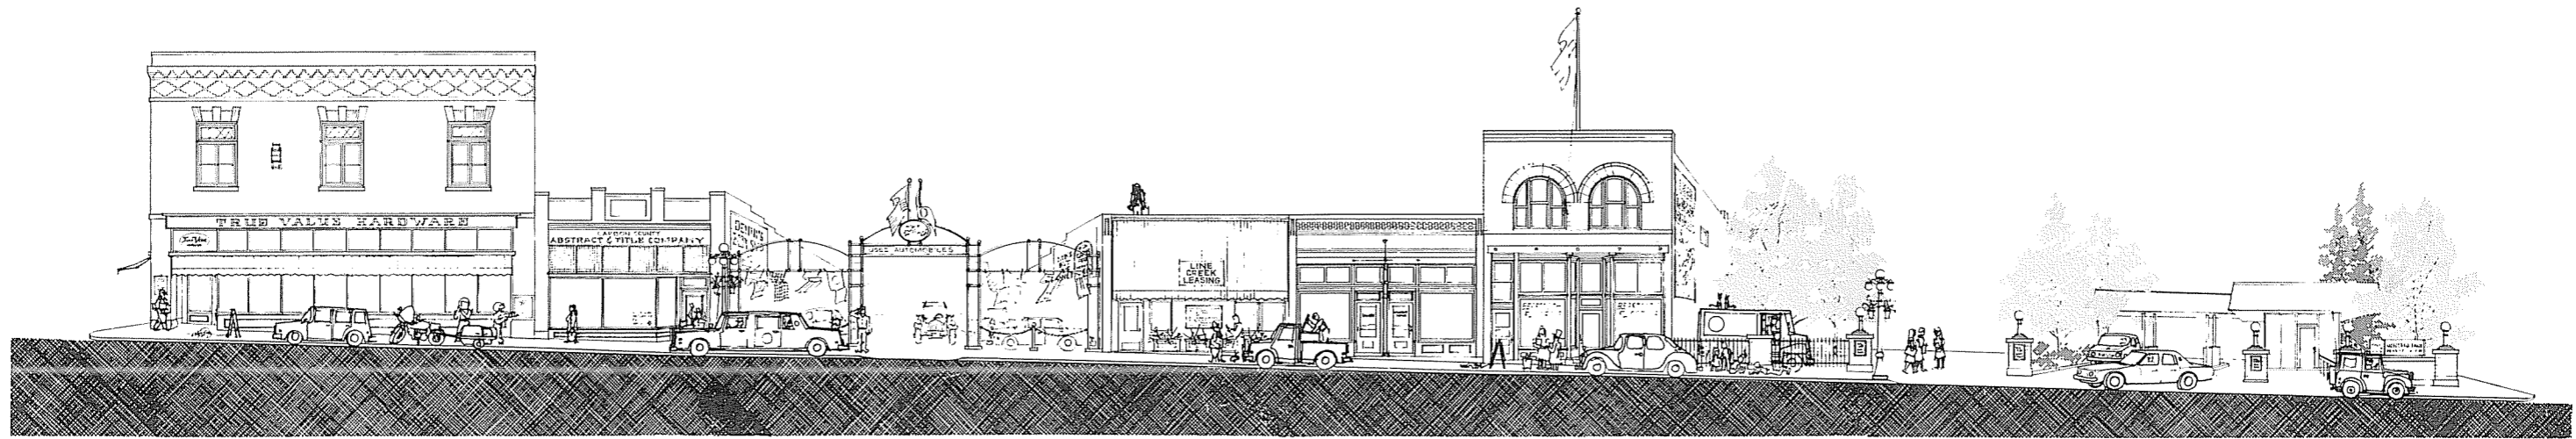
<p>101 North Broadway True Value Hardware/ Masonic Lodge Restore storefront with transom. Disguise or replace second story glazing. Historic colors. Listed signage North sidewalk community signage</p>

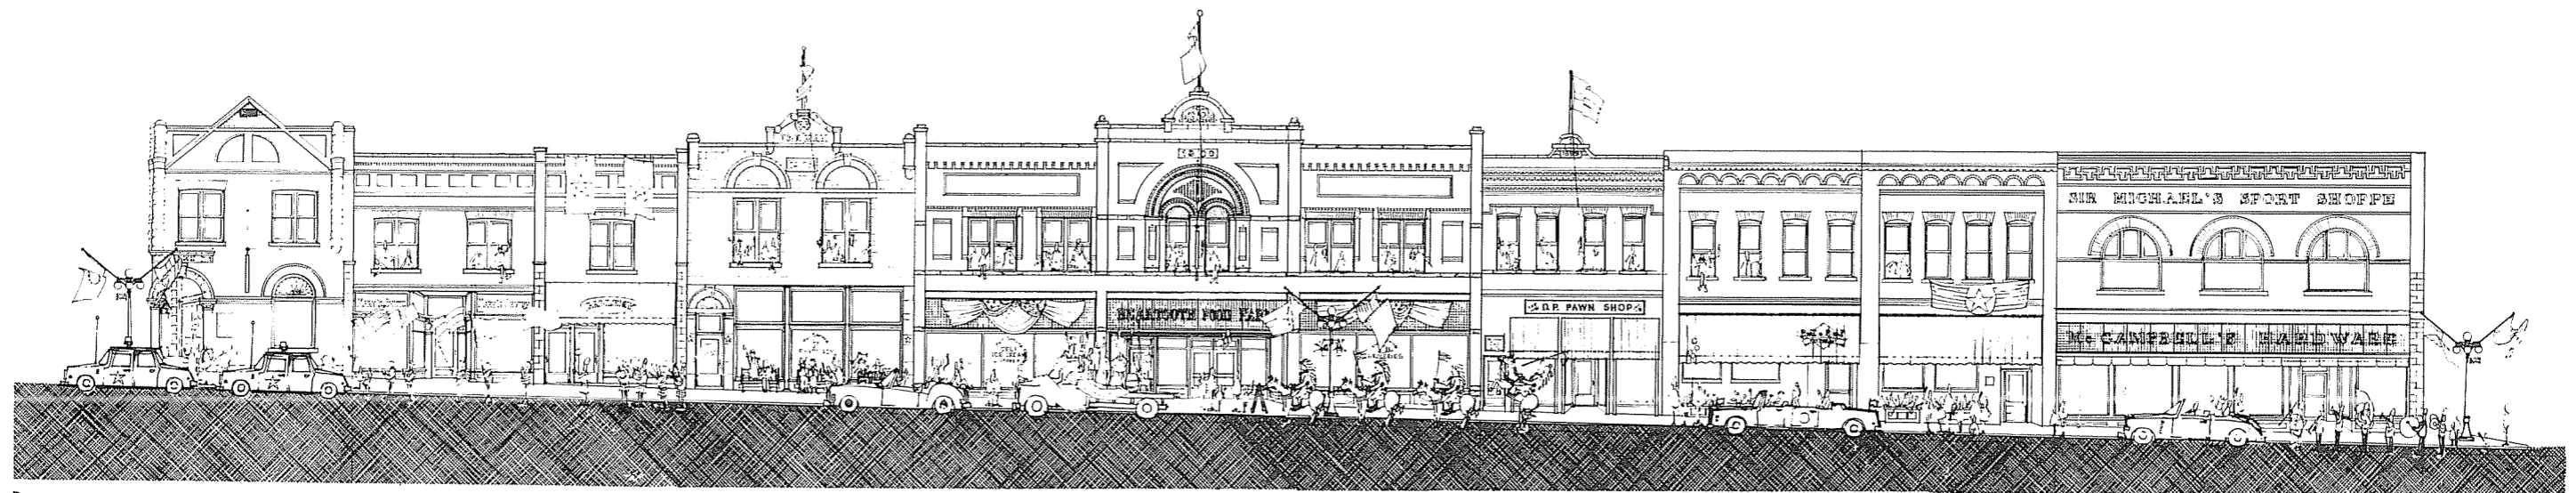
<p>1 North Broadway Carbon County Bank Building Smaller projecting sign- age Relocate power line</p>

<p>15 North Broadway Awnings door replace- ments, facade signage Flagpole at roof</p>

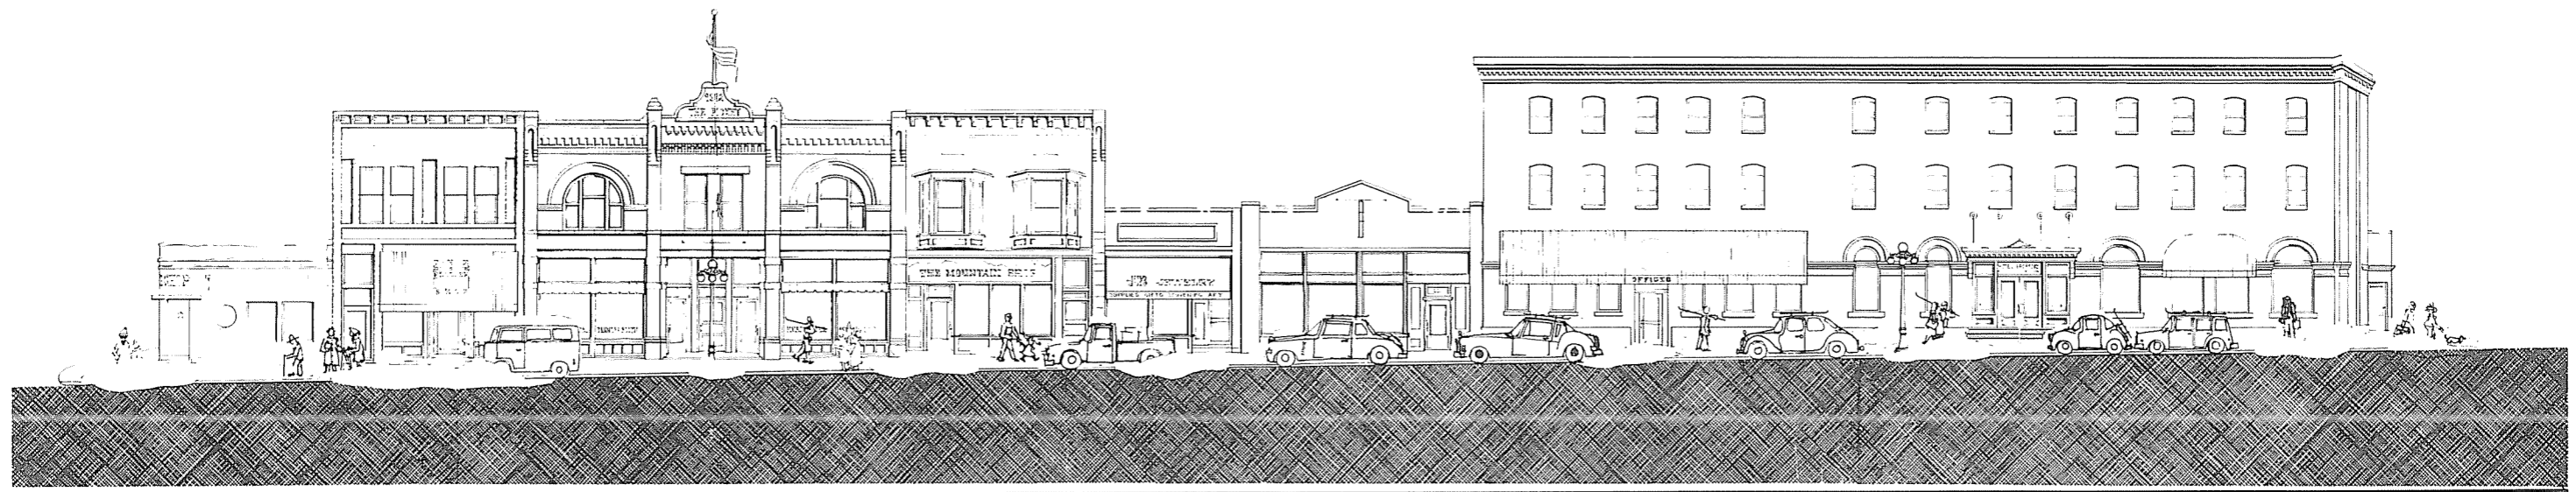
<p>28 North Broadway Restore period facade. Raise parapet. Period colors. Facade signage.</p>	<p>26 North Broadway Color sidewalk as front. Sidewalk community signage.</p>	<p>22 North Broadway Marchello Building/ The Headliner Restore parapet. Projecting and window signage. Flagpole at roof.</p>	<p>16 North Broadway The Mountain Shop Signage within original transept area, with lighting recessed in bay window bases. Storefront panelization.</p>	<p>14 North Broadway JK's Store Awning with signage.</p>	<p>12 North Broadway Hegen's Plumbing and Heating Historically compatible false front with transom. Historic colors. Projecting signage.</p>		<p>2 North Broadway Pollard Hotel Restore historic entry canopy and steps. Restore or disguise arched windows. Disguise blocked upper-story windows. Historic colors entire facade. Awning with signage north portion. Awning south twin window. Entry signage. Relocate sewer line.</p>

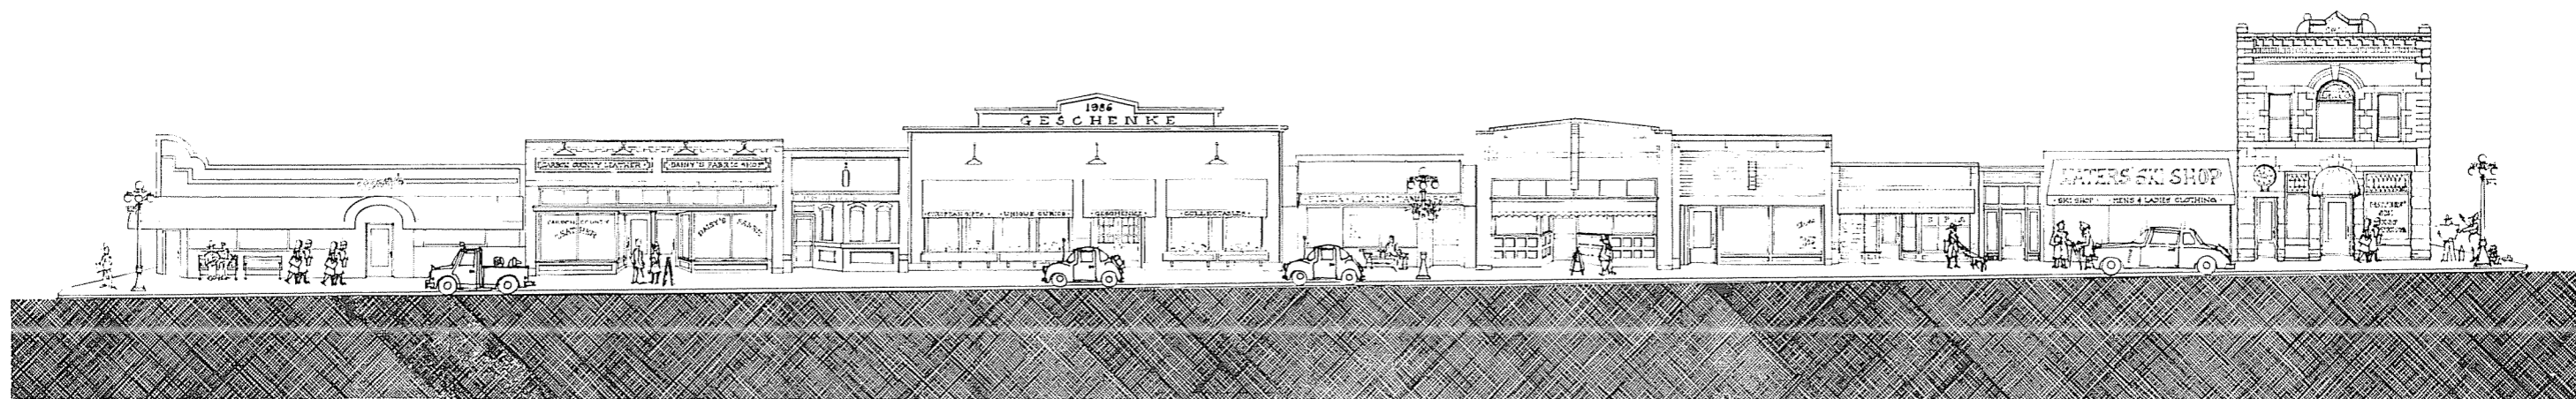
<p>2 South Broadway Stoney's Historically compatible false front with corner restore. Period colors. Awning. Facade signage.</p>	<p>4 South Broadway Carbon County Leather Restore storefront and transom. Historic colors. Facade signage with lighting. Window signage.</p>	<p>6 South Broadway Daisy's Fabric Shop Restore storefront and transom. Historic colors. Facade signage with lighting. Window signage.</p>	<p>8 South Broadway Bruersma Jewelers Historically compatible brick facade. Projecting signage.</p>	<p>12 South Broadway Geschenke European Gifts Historically compatible false front. Awning with signage. Facade signage and lighting.</p>	<p>14 South Broadway Red Lodge Mini Mall Metal canopy with signage.</p>	<p>Restore storefront Historic colors Awning. Restore rear signage.</p>	<p>16 South Broadway Red Lodge Cafe Historically compatible false front. Projecting signage complimentary to historic signage at 16 S. Broadway.</p>	<p>20 South Broadway Mark Schuertz Public Accountant Restore false fronts with original division. Awning. Window signage.</p>	<p>22 South Broadway Waters Clothing Awning with signage complimentary to 24 South Broadway.</p>	<p>24 South Broadway Waters Clothing Restore storefront. Entrance awning. Window signage. Disguise firewall alterations.</p>

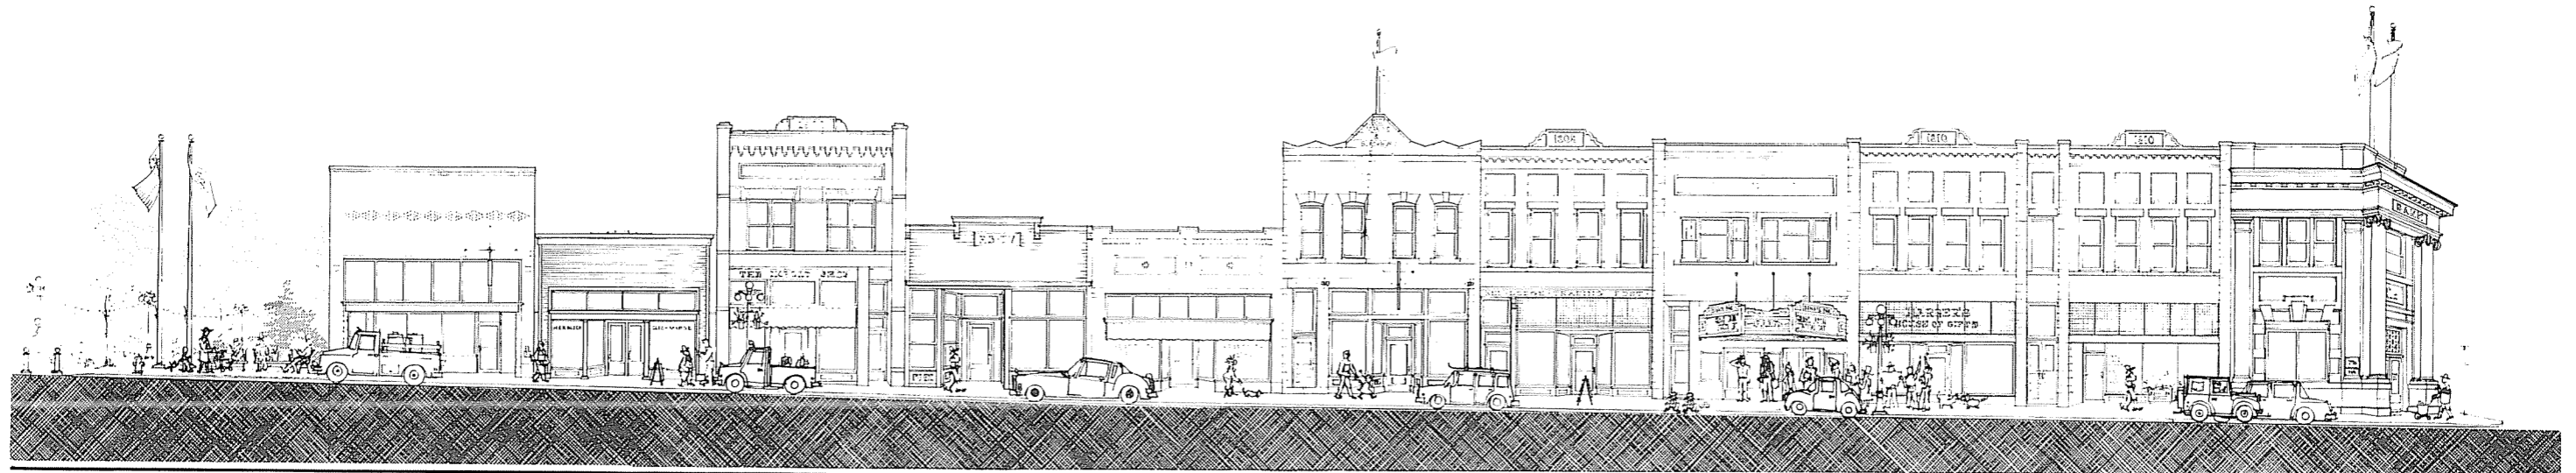
<p>23 South Broadway Pride Park Develop in conjunction with 12th St. Market North sidewalk brick color. Tourist directory Public information and services Historic view for east side hillside mining ruins. Market area paving. Additional lighting and seating. Tree canopy and landscaping. Flagpoles. Preserve fire lane.</p>	<p>21 South Broadway Flash's Studio & Gift Shop Color sidewalk as front. Projecting signage over entry. Sidewalk signage.</p>

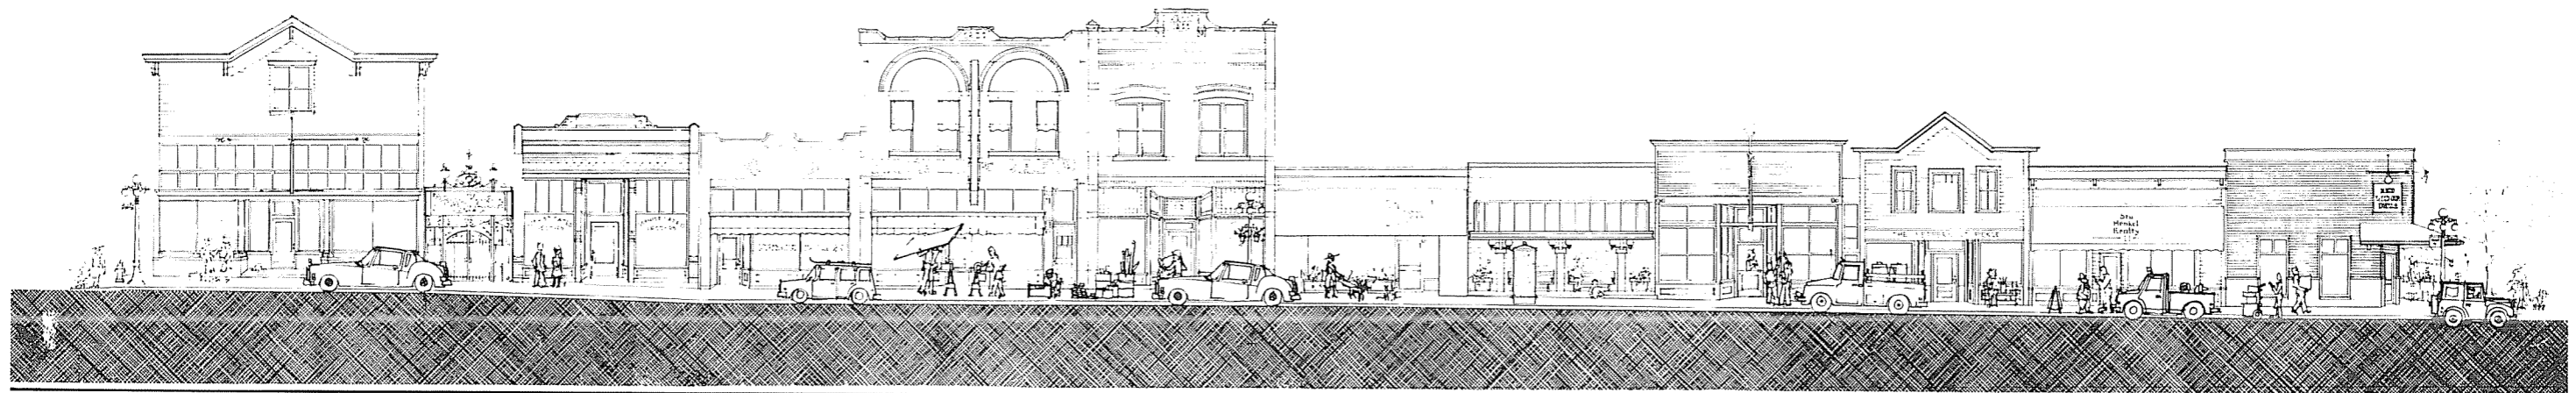
<p>123 South Broadway Carbon County Coal Company Restore facade with transom. Restore side- walls. Develop side- entry. Historic colors. Illuminated projecting signage. Sidewalk community signage.</p>	<p>121 S. Broadway Plus & Karin's Place Develop lighting and top of gateway.</p>	<p>119 South Broadway Sophisticated Second Historic colors facade and sidewalk. Window signage.</p>	<p>117 South Broadway Natalie Lounge Restore storefront with transom. Roll out awning to match Natalie Cafe. Window signage.</p>	<p>115 South Broadway Natalie Cafe Restore storefront with transom. Historic colors facade and side- wall. Awning second story windows. Refin- ish and restore new projecting signage. Restore storefront window mesh.</p>	<p>113 South Broadway Cotton Cousin' Shirts- works Redetail storefront. Historic colors store- front and sidewalk. Sidewalk community signage.</p>	<p>111 South Broadway Montana Power Company Increase height false front with historic- ally compatible finish. Awning with signage.</p>	<p>109 South Broadway Montana Power Substa- tion Develop as public seating area: block wall full height, glazed canopy, seal platform, lighting, advertisements.</p>	<p>107 South Broadway The Shag Restore facade with transom. Historic colors, front and sidewalk. Rescaled projecting signage. Illuminated.</p>	<p>105 South Broadway Peppermint Pickle Restore facade. Historic colors. Lateral signage.</p>	<p>103 South Broadway Stu Merkel Realty Historically compatible false front. Historic colors. Awning with signage.</p>	<p>101 South Broadway Red Lodge Drug Storefront: historic- ally compatible false front wrapping around corner with deep eave as entry canopy. Window pattern multicolor. Illuminated corner signage. Storewall: Market stall awning and rain gutter. Flower and water services. Pavement and trees as market area.</p>

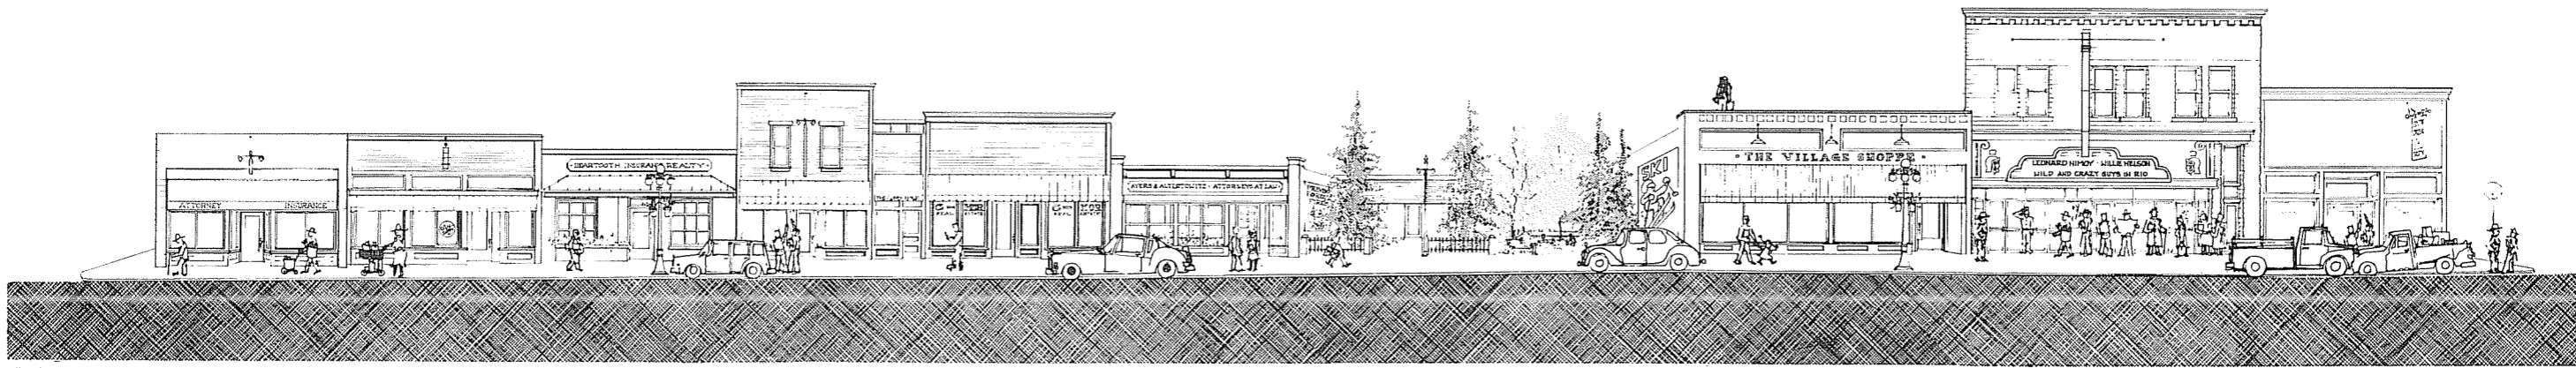
<p>102 South Broadway State Farm Insurance</p> <p>Restore stone facade or develop compatible stucco facade. Restore store front. Historic colors. Awning and projecting signage.</p>	<p>104 South Broadway City Bakery</p> <p>Historically compatible false front with transom. Historic colors. Awning. Projecting signage and neon window signage.</p>	<p>106 South Broadway Bearcloth Insurance</p> <p>Compatible brick storefront. Window mullions. Metal tipped canopy. Facade signage.</p>	<p>108 S. Broadway Original Salt-water Taffy</p> <p>Restore facade, storefront and transom. Historic colors. Awning. Projecting signage.</p>	<p>109 S. Broadway The Cobby Hole</p> <p>Restore facade, storefront and transom.</p> <p>Historic colors. Awning with signage.</p>	<p>110 South Broadway C-Mor Realty</p> <p>Restore facade, storefront and transom. Historic colors. Awning. Window signage.</p>	<p>112 South Broadway Ayers & Alterowitz</p> <p>Historically compatible facade screen at sidewalk line. Historic colors, front and sidewalk. Awning. Facade signage. Sidewalk community signage.</p>	<p>114 South Broadway USA</p> <p>Historically compatible siding at entrance canopy. Historic colors, fence at sidewalk. Landscape with adjacent lot. Free-standing signage.</p>	<p>116 South Broadway Landscape with adjacent setback, complete closure to 118 South Broadway. Seating, play area.</p>	<p>118 South Broadway Village Shoppe</p> <p>Historic colors, front and sidewalk. Facade signage with lighting. Sidewalk community signage.</p>	<p>120 South Broadway Simon Theater</p> <p>Restore period storefront. Restore upstairs entry. Historic colors front and sidewalk. Redesign reader board to compliment storefront. Move projecting sign. Restore neon.</p>	<p>124 South Broadway Snow Creek Saloon</p> <p>Restore false front with transom. Restore entry. Siding and trim at sidewalk as front. Historic colors. Illuminated projecting signage.</p>
