RED LODGE
COMMERCIAL HISTORIC DISTRICT
REVITALIZATION
MASTER PLAN

1986

Carbon County, Historic Preservation Office • Red Lodge, Montana
Michels Raffety Architects • Livingston, Montana

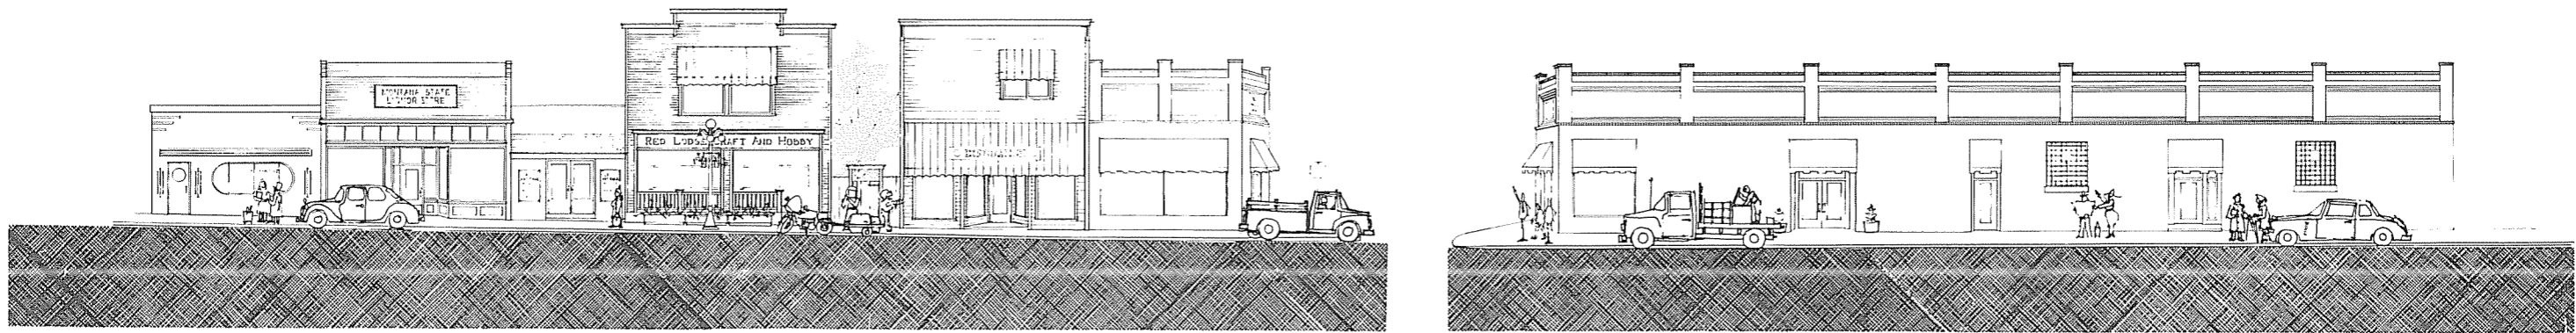
211 S. Broadway
G. K. Braumont, Optometrist
Restore period integrity with decorative trim
Period colors, including sidewalk window signage

206 S. Broadway
Wash-Dry Laundromat
Restore false front with transom
Historic colors
Repair awning
Facade signage

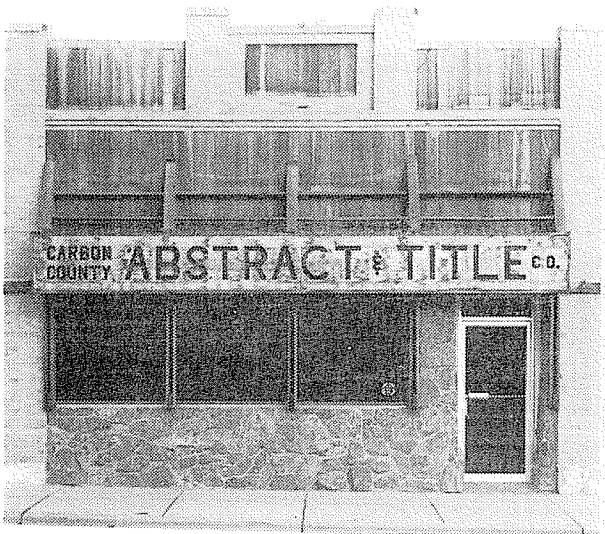
Fig. 49. Existing 105 N. Broadway, Carbon County Abstract & Title Company.

cedar siding, creating a false “historic” appearance. The building appears closer to its original pattern today than it did ten years ago, but the building could be enhanced further. Beneath the three cedar paneled areas in the cornice are brick. By removing the panels the beautiful brick relief of the cornice can be fully exposed and appreciated. The cedar siding, a material with its own intrinsic

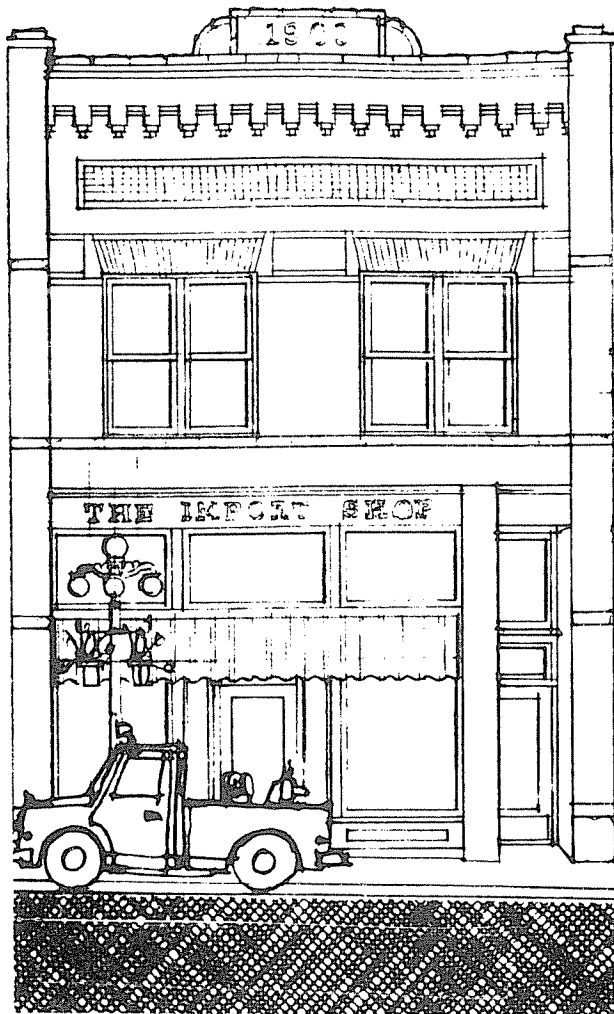
Restore facade and storefront with transom.
Historic colors. Awning.
Lintel signage.

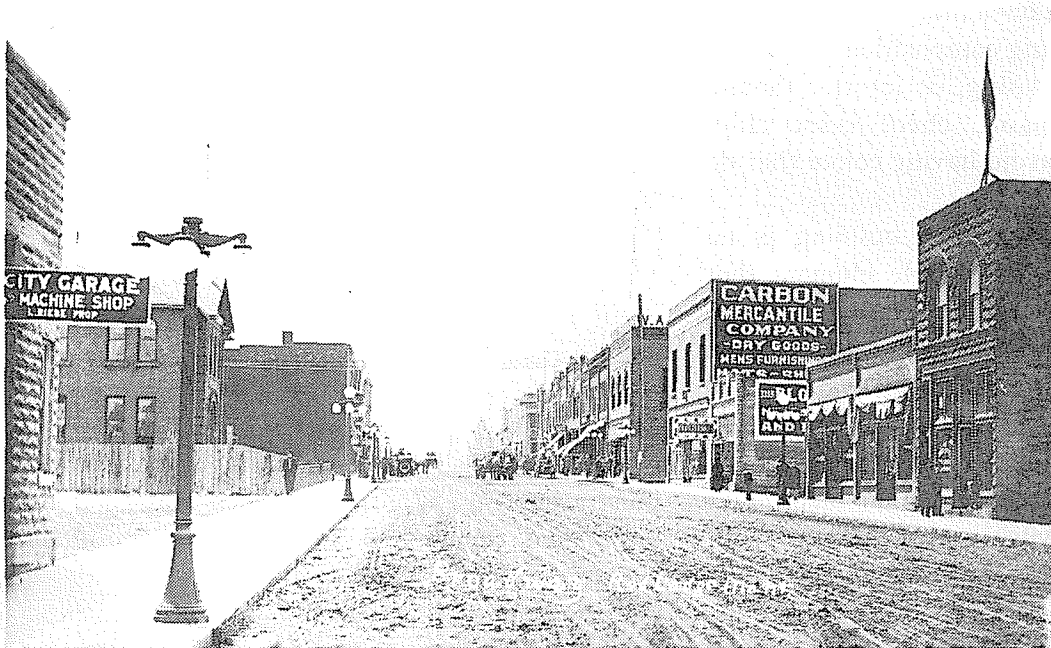
needed, the north facade wall is a good place for a illustration (Fig. 57). This location gives good visibility and remains in keeping with traditional signage.

Fig. 57. Historically, side-walls of building were used for advertisement

Empty spaces caused by the removal of a building destroyed by fire can be an eyesore in the heart of the district. One alternative to a weed patch is screening it from sight, as seen earlier in Figure 57. Another alternative is to use the space Broadway, page 45, suggests creating a scene depicting the coal mining years. The artifacts could be a permanent display until the economy is conducive to further commercial development. Cooperation between the property owner, the city, and possibly a public service group could accomplish these improvements.

Other unifying elements that could bond the district are historic signs painted on blank side walls, either for advertisements or to promote the area's recreational and annual activities. (See Figure 57 for sidewall signage.) Mural-like signs can enhance the appearance of the side wall and are an effective means of letting travelers know what Red Lodge has to offer.

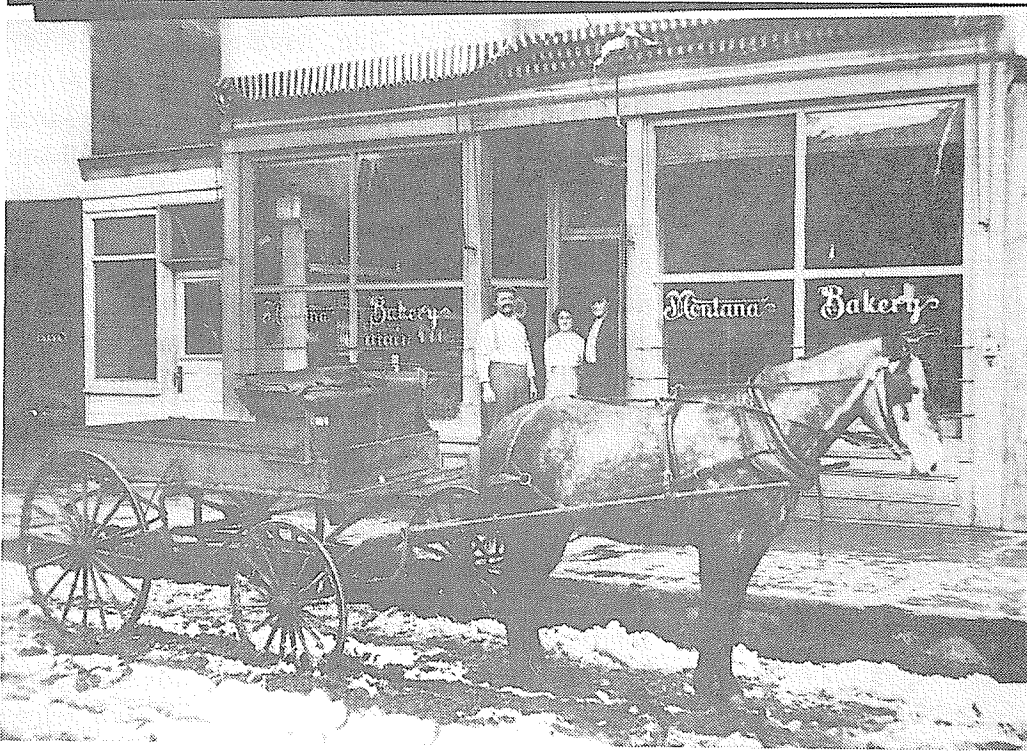
Fig. 60. Early photo ca. 1900, Montana Bakery currently C-Mor Realty

Investigation of historic photographs revealed three distinct wooden cornices capping the false fronts of horizontal clapboard siding. The Montana Bakery photograph shows the earliest storefront pattern on the current C-Mor Real Estate. The initial step for rehabilitation of these buildings

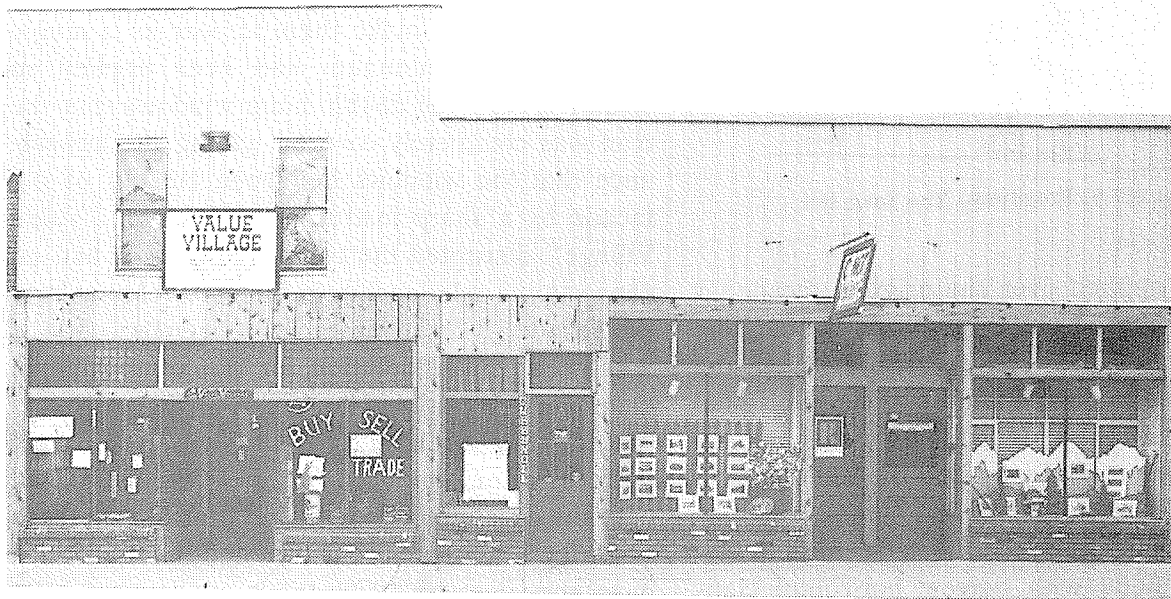
One And One-Half-Story Wood: The Montana Bakery (C-Mor Real Estate) at 110 S. Broadway and the two adjacent buildings to the north are a group of early wood frame commercial buildings with false fronts. Examination of the existing condition survey shows the upper portion of the three buildings paneled with vertical ribbed aluminum in an attempt to make them appear as a single building. The aluminum had been applied so closely around the double-hung windows that the trim was completely covered, giving the appearance that the windows had been cut out of the facade by a sharp instrument. The sign "Value Village" disrupted the composition, as it had no proportional relationship to the other elements of the facade. It is an example of signage applied without any consideration for the compositional elements or the area of the building upon which it is placed. The three storefront entryways still reflect patterns commonly used in the 1920s and 1930s, with the exception of some alterations to the base and trim. The rustic cedar trim and the used-brick base appear to be 1970s-1980s applications over original materials.

would be to remove the aluminum cladding. If upon removal of the aluminum the original materials were discovered to be intact, the owner could then contact the Carbon County Historic Preservation Office or the SHPO for an evaluation of historic integrity in order to qualify for rehabili-

Fig. 61. 108, 108½, 110 S. Broadway before rehabilitation

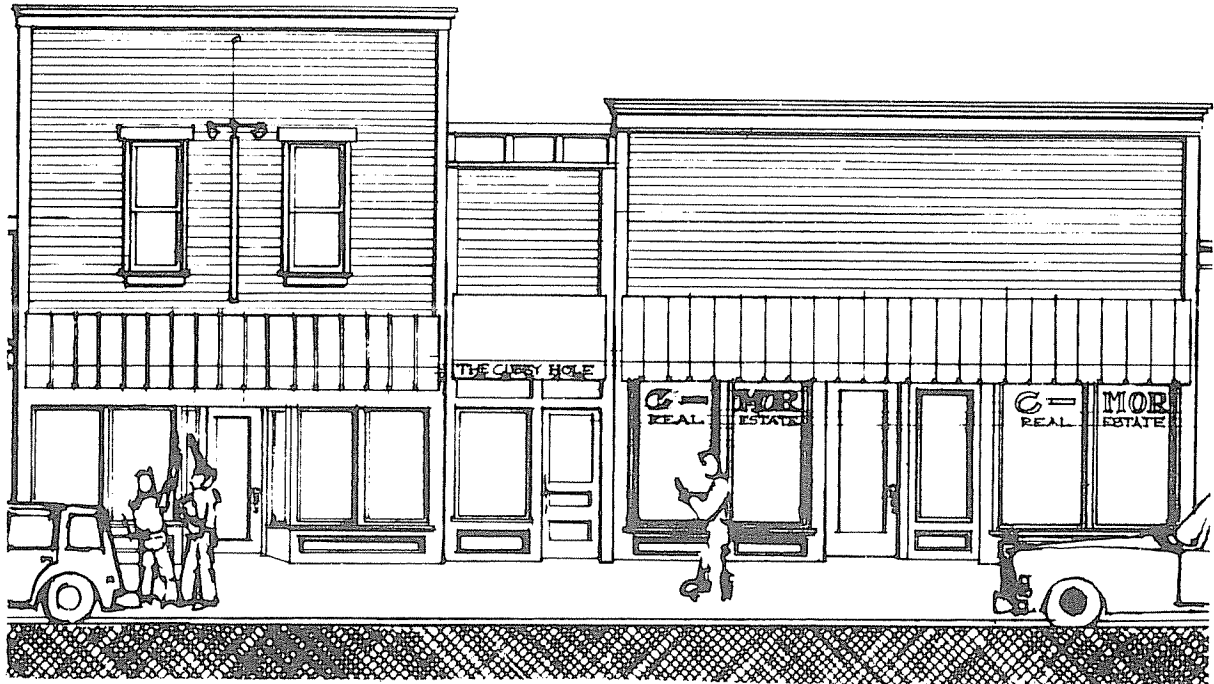
Fig. 62. Design drawing, 108, 108½, 110 S. Broadway, Taffy Pantry, Cubbyhole, C-Mor Realty

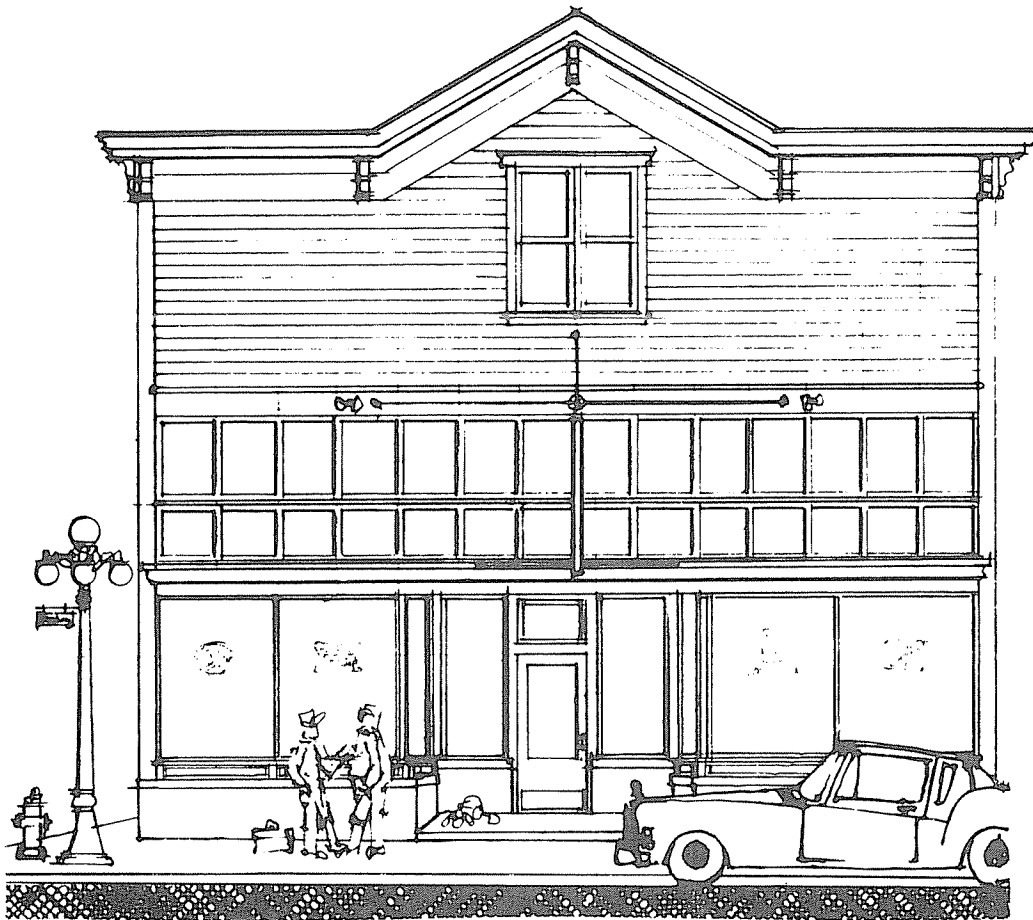
Fig. 65. Proposed 123 S. Broadway, Carbon County Coal Company

Restore facade with transom. Restore side-walls. Redevelop side entry. Historic colors. Illuminated projecting signage. Sidewall community signage.

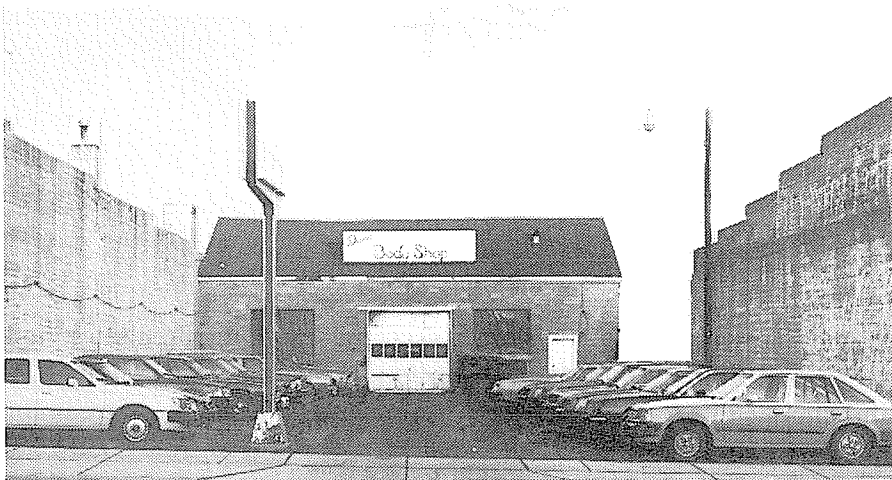
Fig. 68. Existing 109 N. Broadway showing loss of facade plane of street

Set-Back Buildings: Deep set-back buildings break the plane of the street-facades and visually disrupt the continuity of the block. Boundary defining elements shown in Block 38 at 109 N. Broadway, (Denni's Body Shop and Used Car lot) or a fence and column detail as shown in Fig. 71 at 119 N. Broadway can be effective devices for beautification and signage. A fence to define the boundary around the new drive-in bank would distract the eye from the new construction and allow the historic-type wrought iron fencing and brick pilaster to take visual precedence. The fence

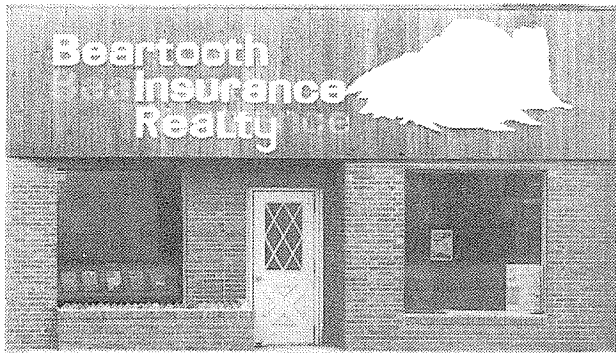
Fig. 72. Existing 106 S. Broadway, Beartooth Insurance, Realty

New Construction: Numerous examples of ways to blend new buildings with the old are interspersed throughout the proposed Block-by-Block designs. Each building must be itself as a unique expression, while it complements the alignment, context, and historical elements of the neighboring buildings. For example, the Beartooth Insurance and Realty located at 106 S. Broadway is a new building that has been constructed with appropriate contemporary materials of brick and plate glass on the sidewalk entry level. The central entry pattern is traditional and readily relates to the district. Elements that do not visually harmonize with the historic fabric of the district are the vertical wood on the upper half of the facade, the size and type of signage, and the type of entry door. Alterations suggested by the redesign include installation of a fixed solid canopy on the vertical wood area. The canopy, detailed in a contemporary style so as to be compatible with the modern facade, relates in form to a traditional awning projection. The sign could be placed in the area above the canopy in a lettering style commonly used for historic signage such as Helvetica or Roman. These two new elements would attract the eye and de-emphasize the vertical wood upper facade. Other suggested alterations are the replacement of the Tudor style residential door with a standard commercial door of either wood or metal, and the addition of wood mullion applique to give the windows more character.

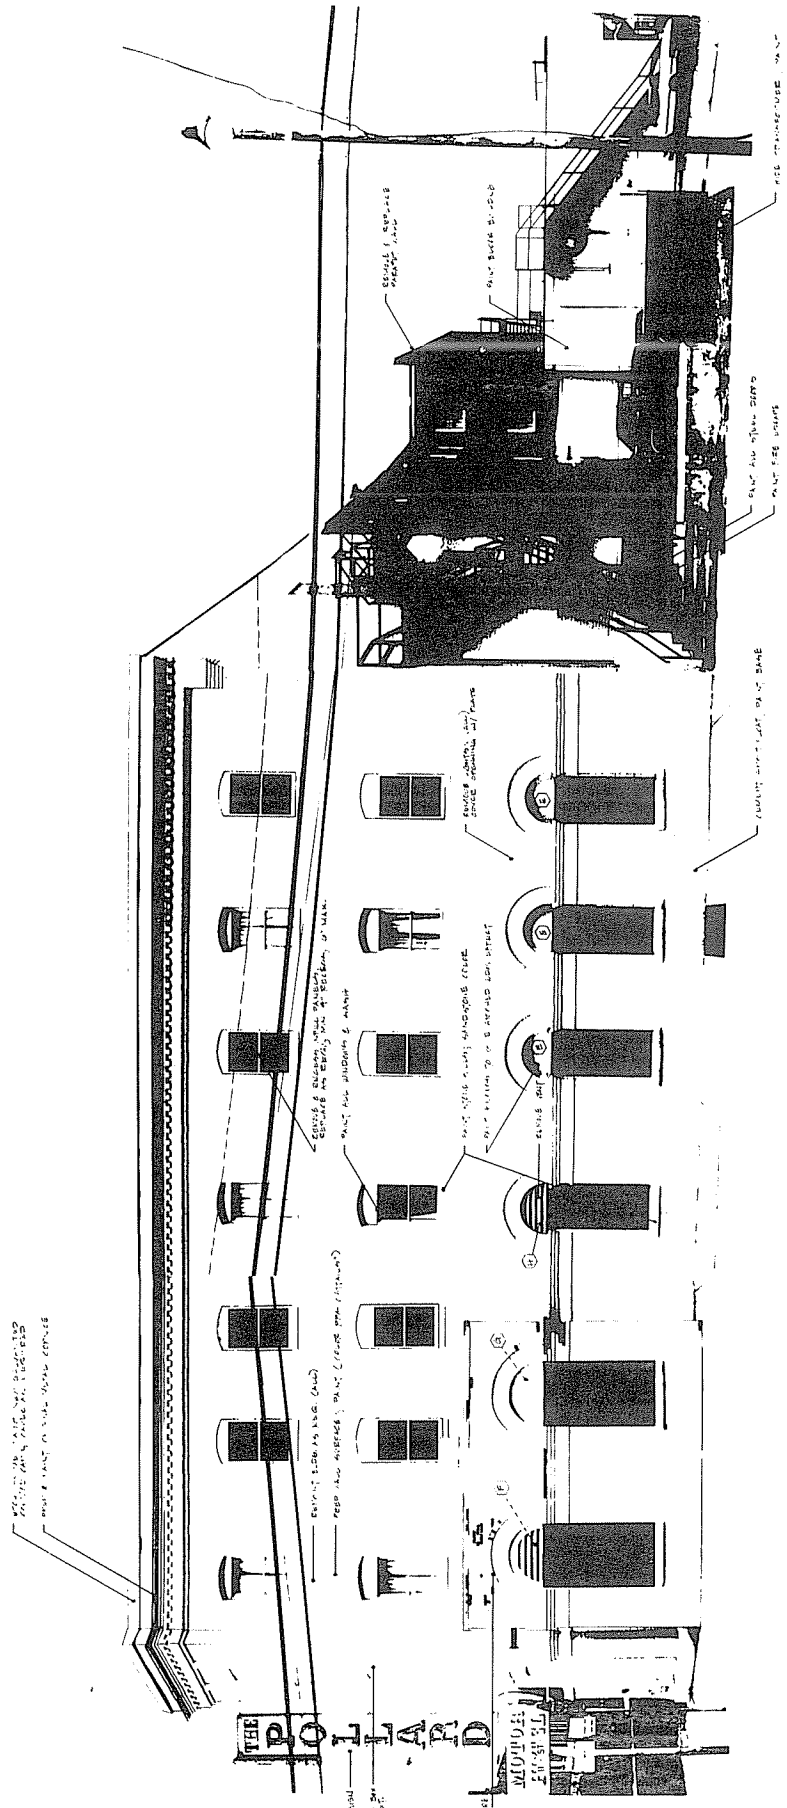
EXISTING SOUTH ELEVATION TO MAJOR IMPROVEMENT. THIS PLACE

Fig. 76. Pollard Hotel working drawing

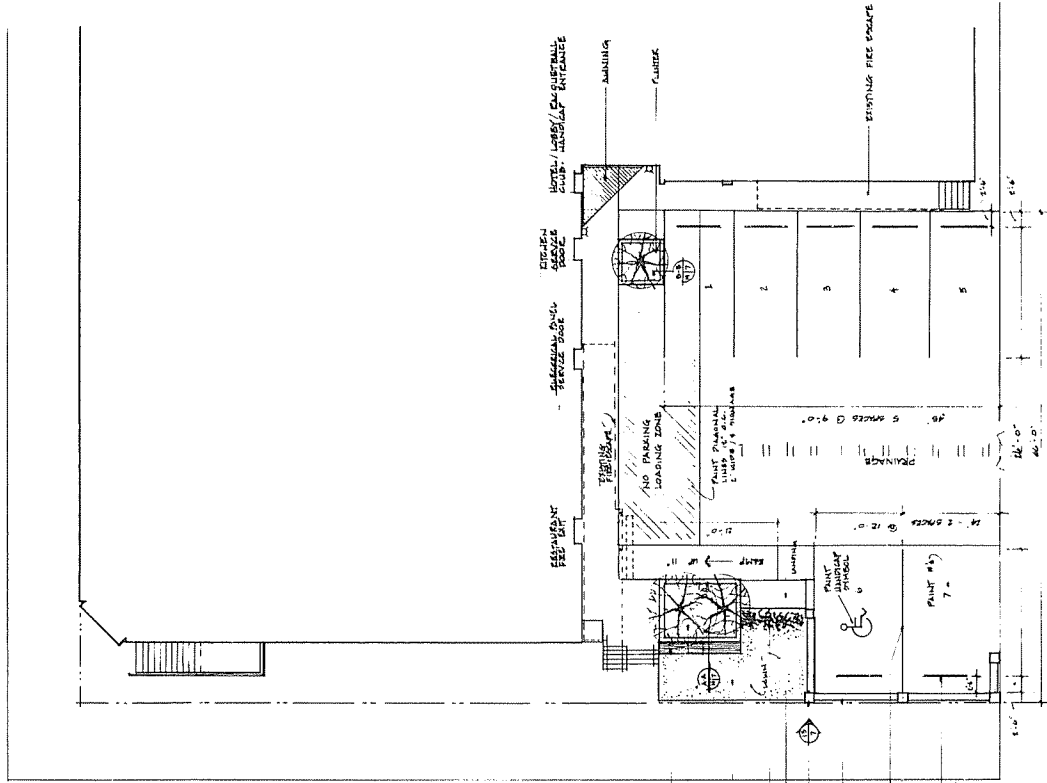
NEW SITE PLAN
SCALE: 1/8" = 1'-0"

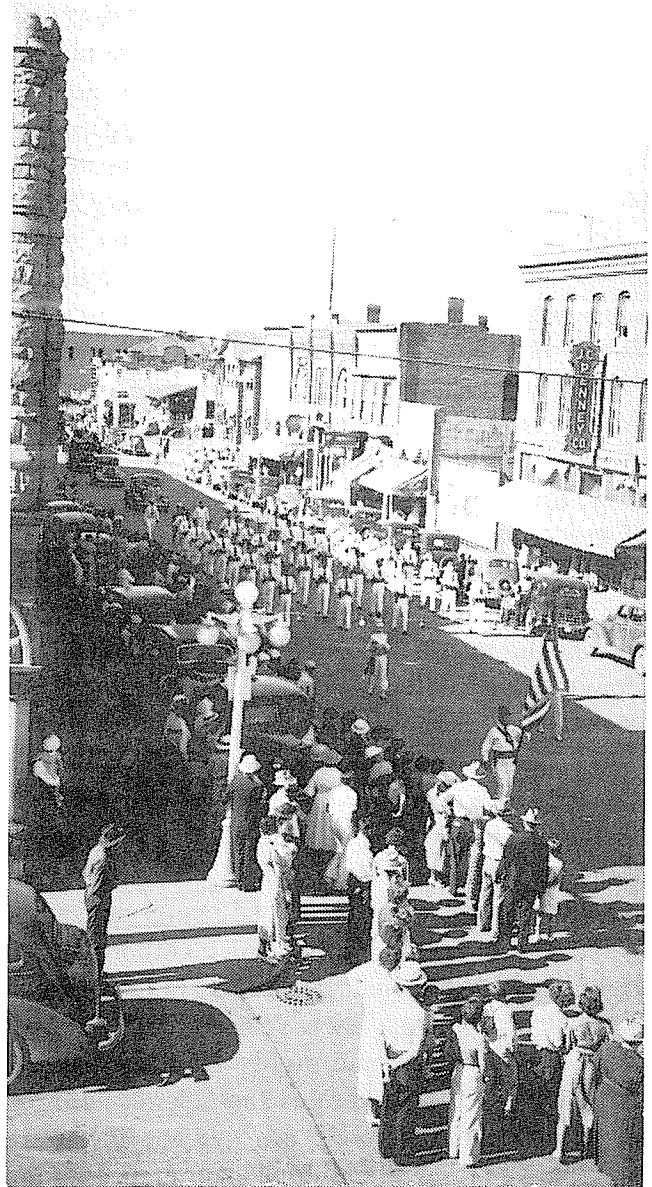
Fig. 95. Broadway looking north, ca. 1940. Note the sign just north of the Penney's building. This sign can screen an unsightly vacant lot and double as an area for promotional advertisement.
