FIGURE 1-1
RED LODGE SUBSIDENCE
MONITORING
PROJECT LOCATION MAP

FIGURE 2-1 RED LODGE SUBSIDENCE MONITORING INVESTIGATION SURVEY AREA

PIONEER
 TECHNICAL SERVICES, INC.

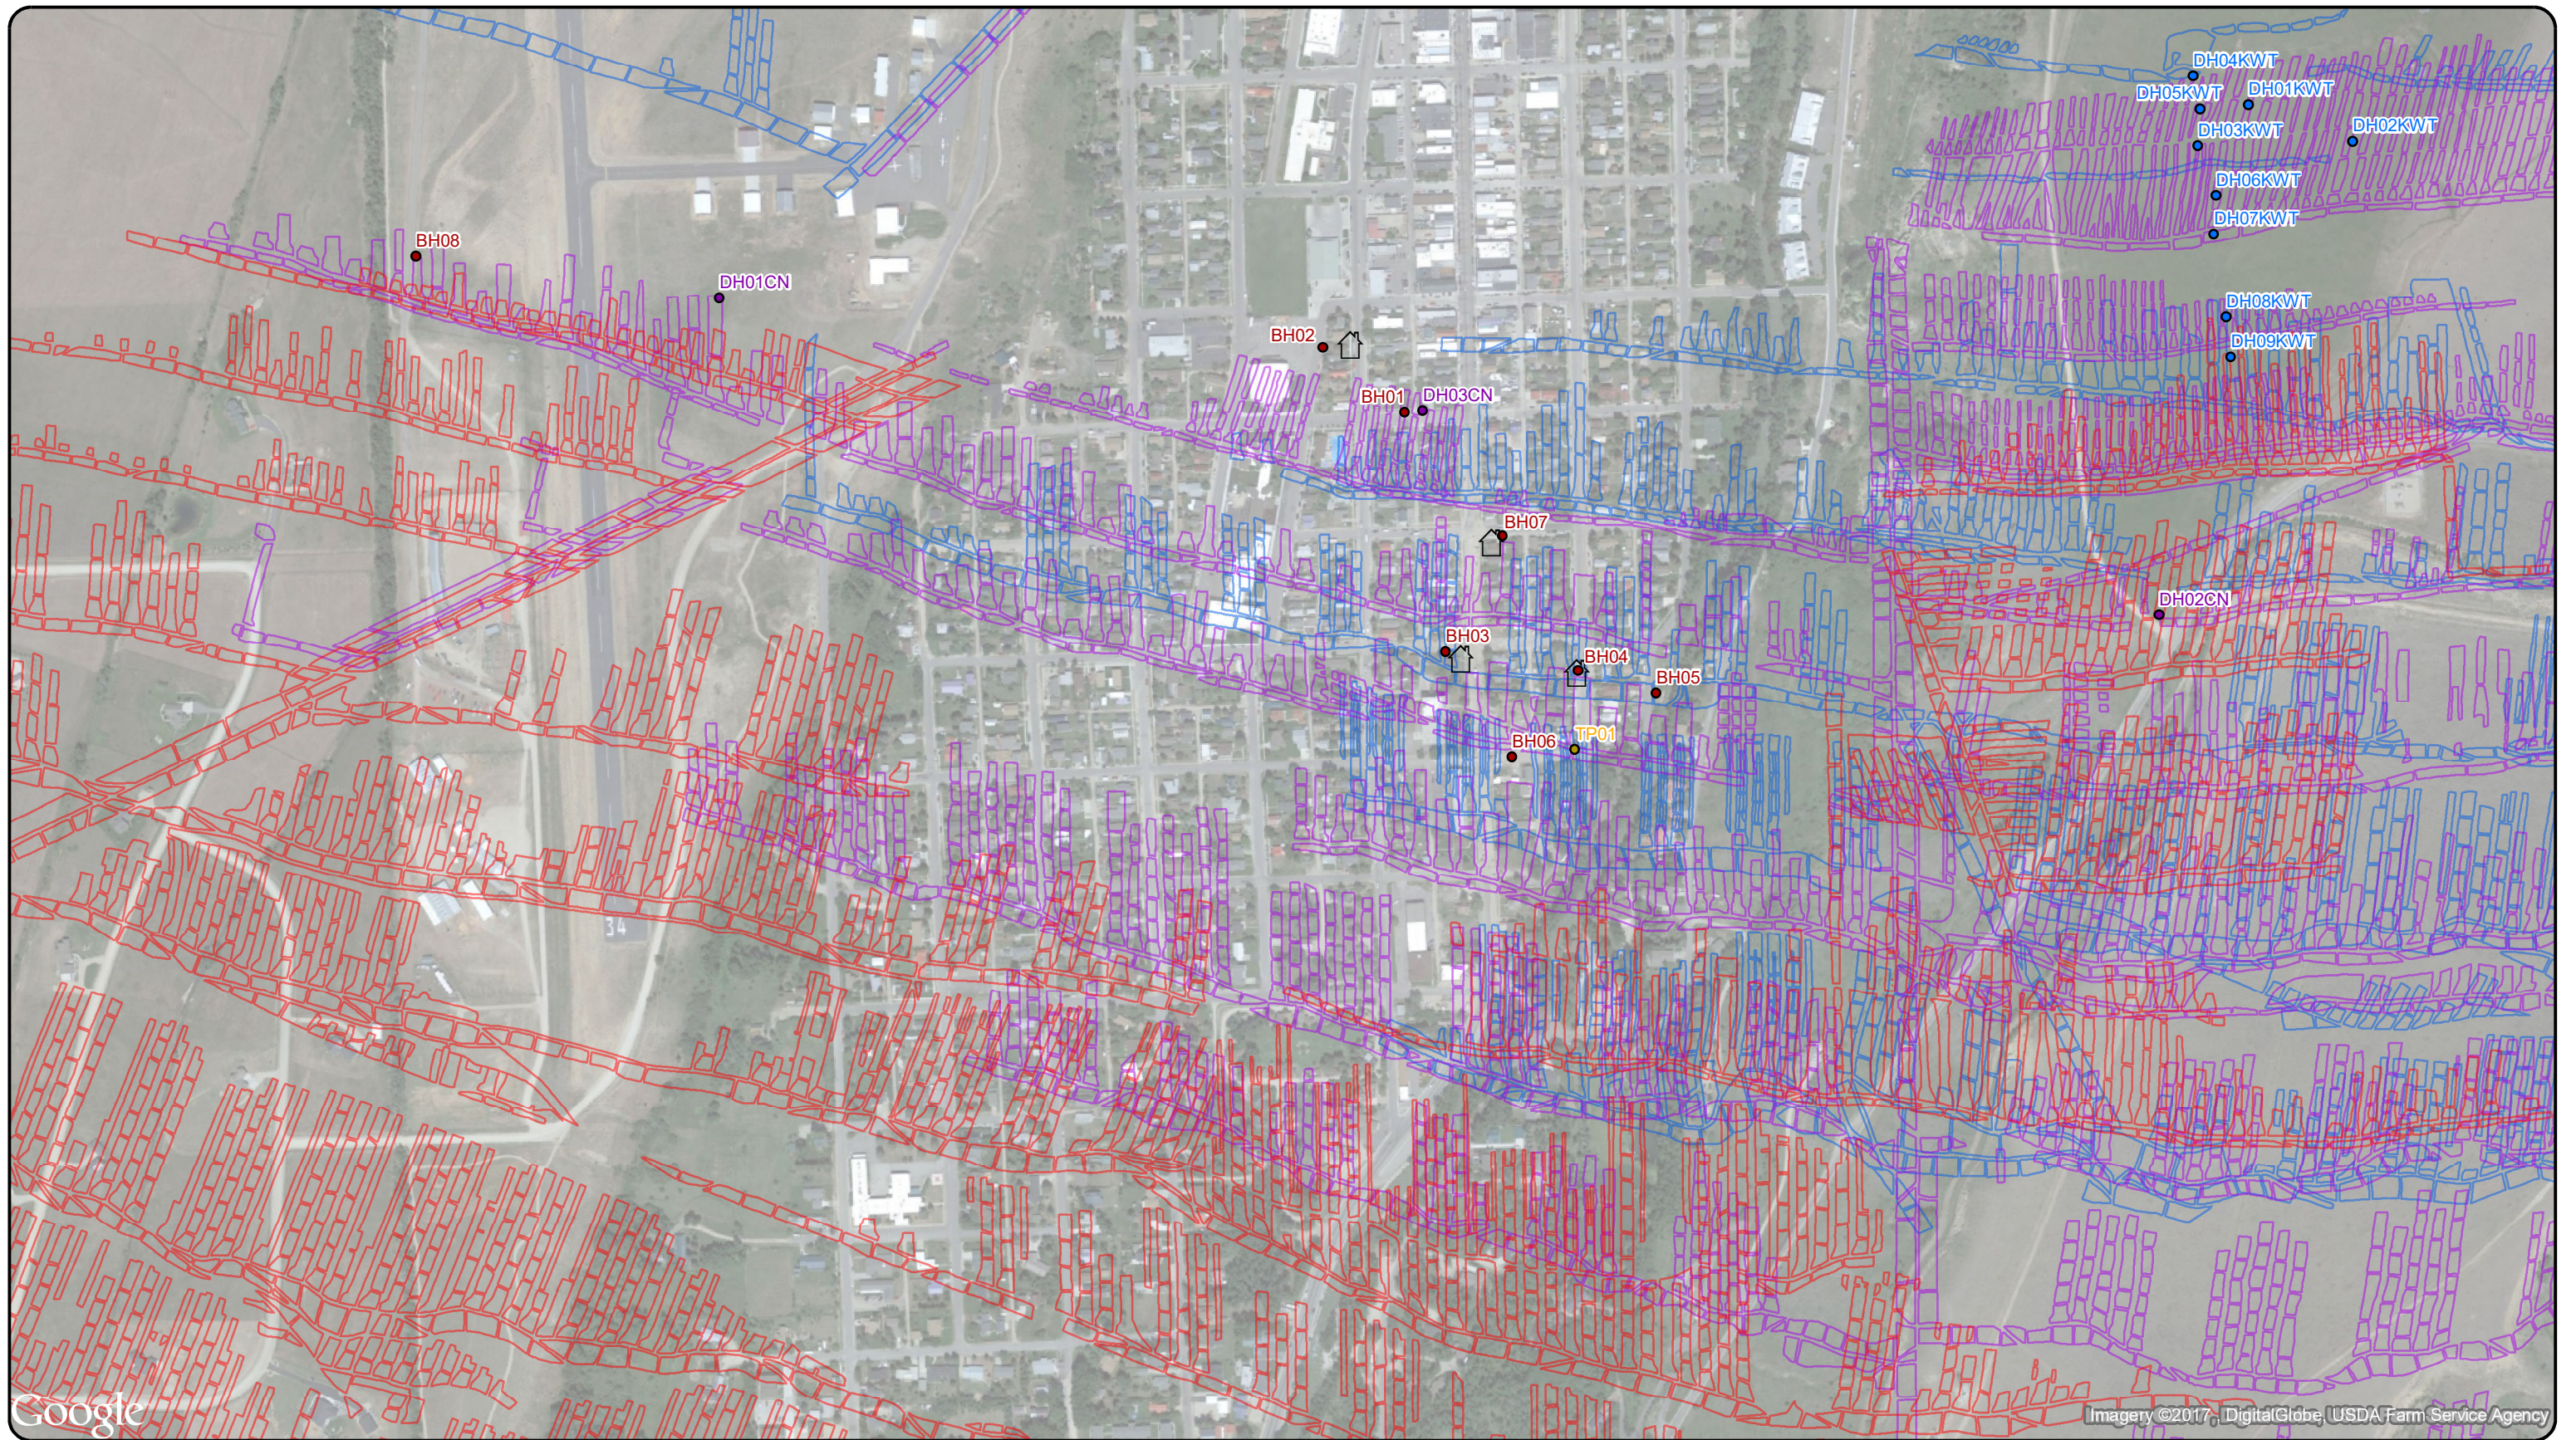
FIGURE 1-2
GENERAL LOCATION OF DOCUMENTED MINE WORKINGS

- LEGEND**
- HOUSE OF INTEREST
 - PIONEER TEST PIT
 - KIEWIT BORE HOLE 1983
 - CHEN-NORTHERN BORE HOLE 1987
 - MINES 1 1/2
 - MINE 4
 - MINE 5
 - PIONEER TECHNICAL BORE HOLE 2014

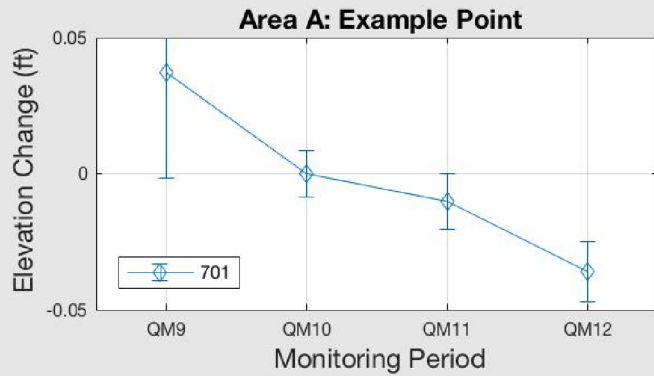
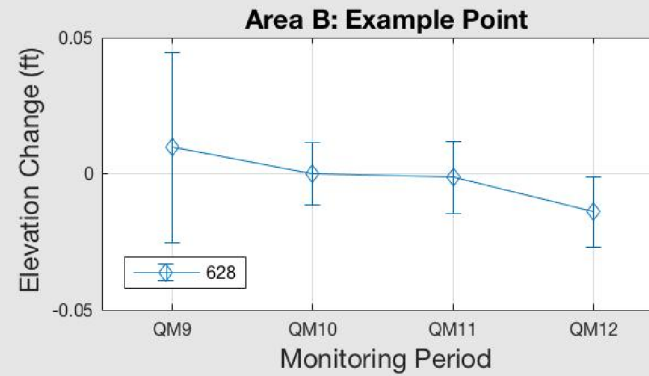
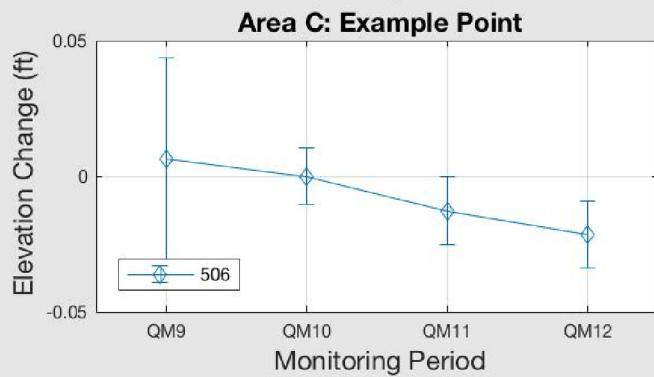
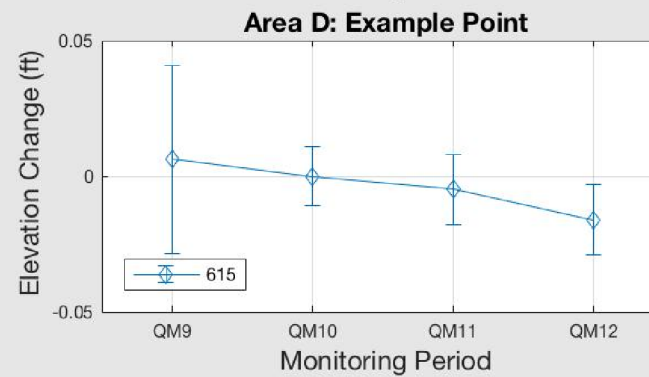
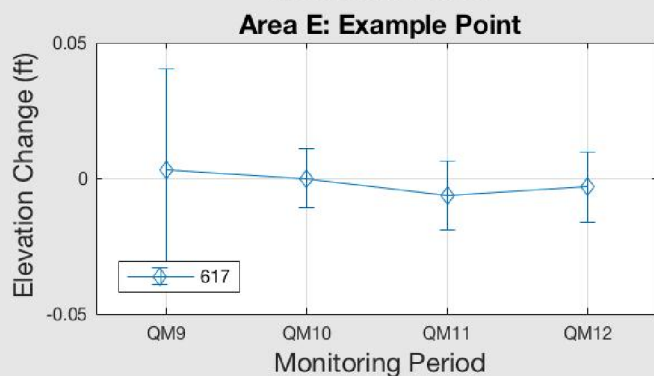
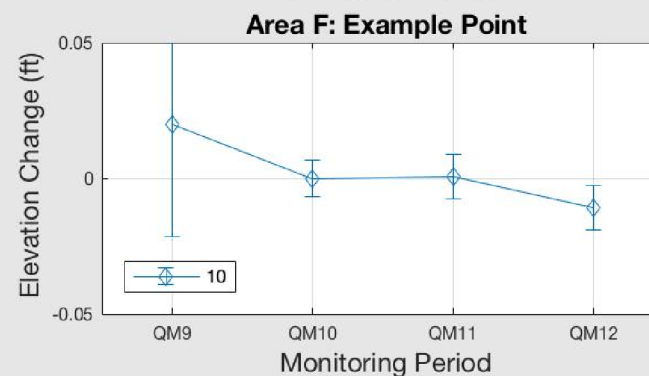
**RED LODGE SUBSIDENCE
 MONITORING INVESTIGATION
 EXAMPLE POINT
 ELEVATION CHANGES**

Red Lodge Subsidence Survey

Elevation Change From QM10 through QM12

Error Bars: 95% Confidence Intervals

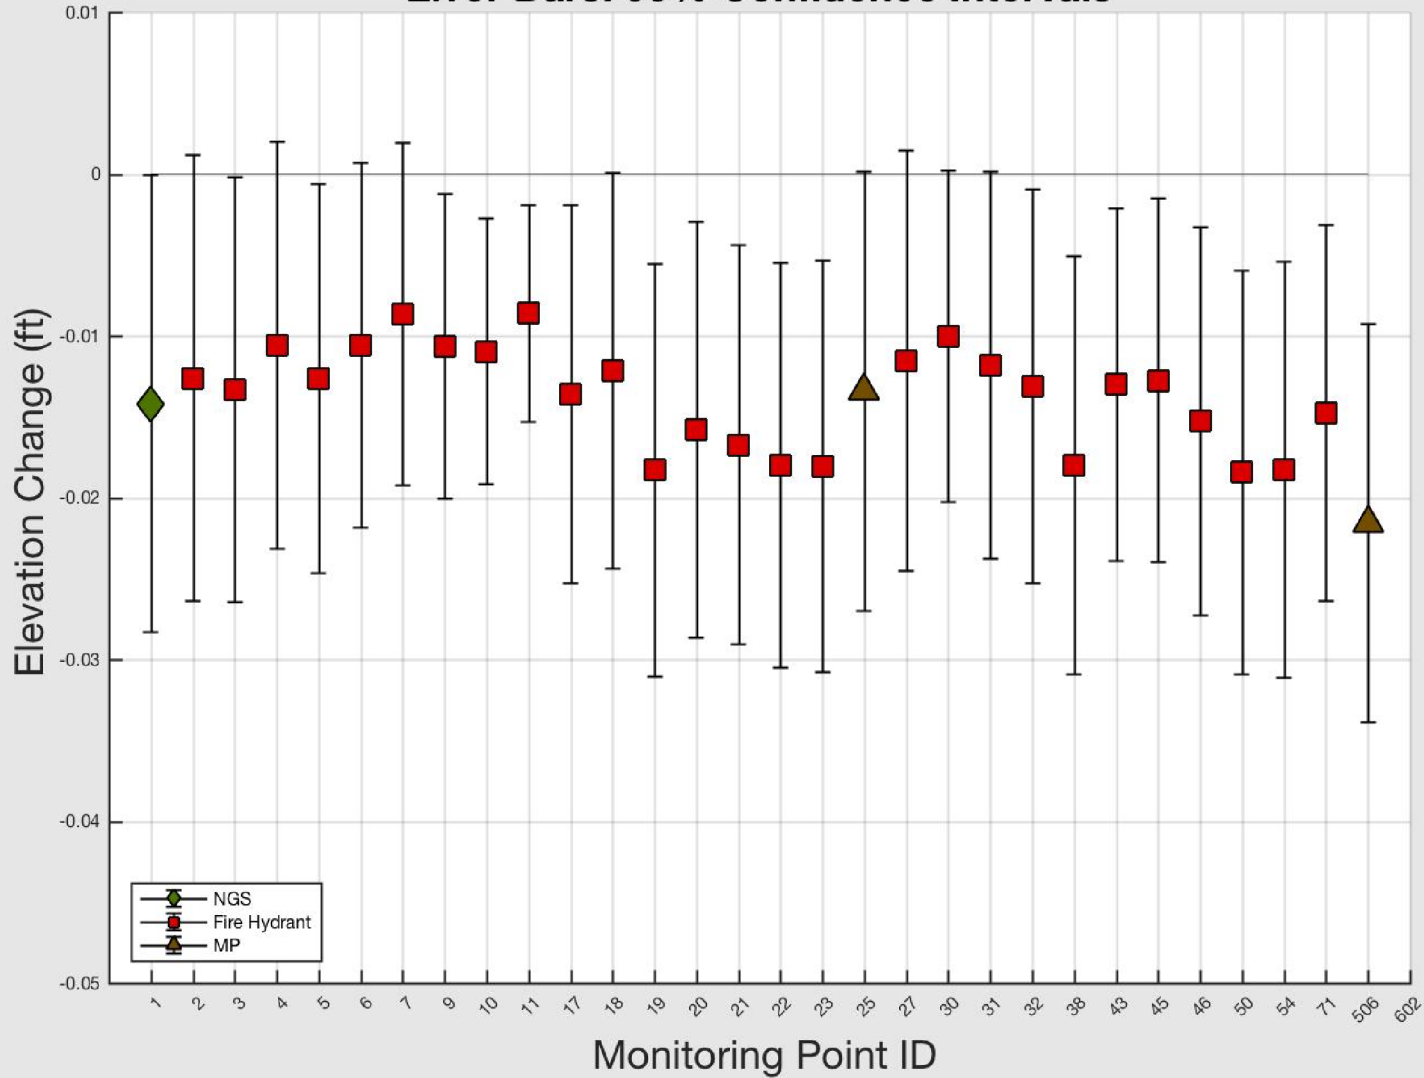
1 OF 4

RED LODGE SUBSIDENCE
MONITORING INVESTIGATION
ELEVATION CHANGES
QM9 THROUGH QM12

Red Lodge Subsidence Survey

Elevation Change From QM10 through QM12

Error Bars: 95% Confidence Intervals

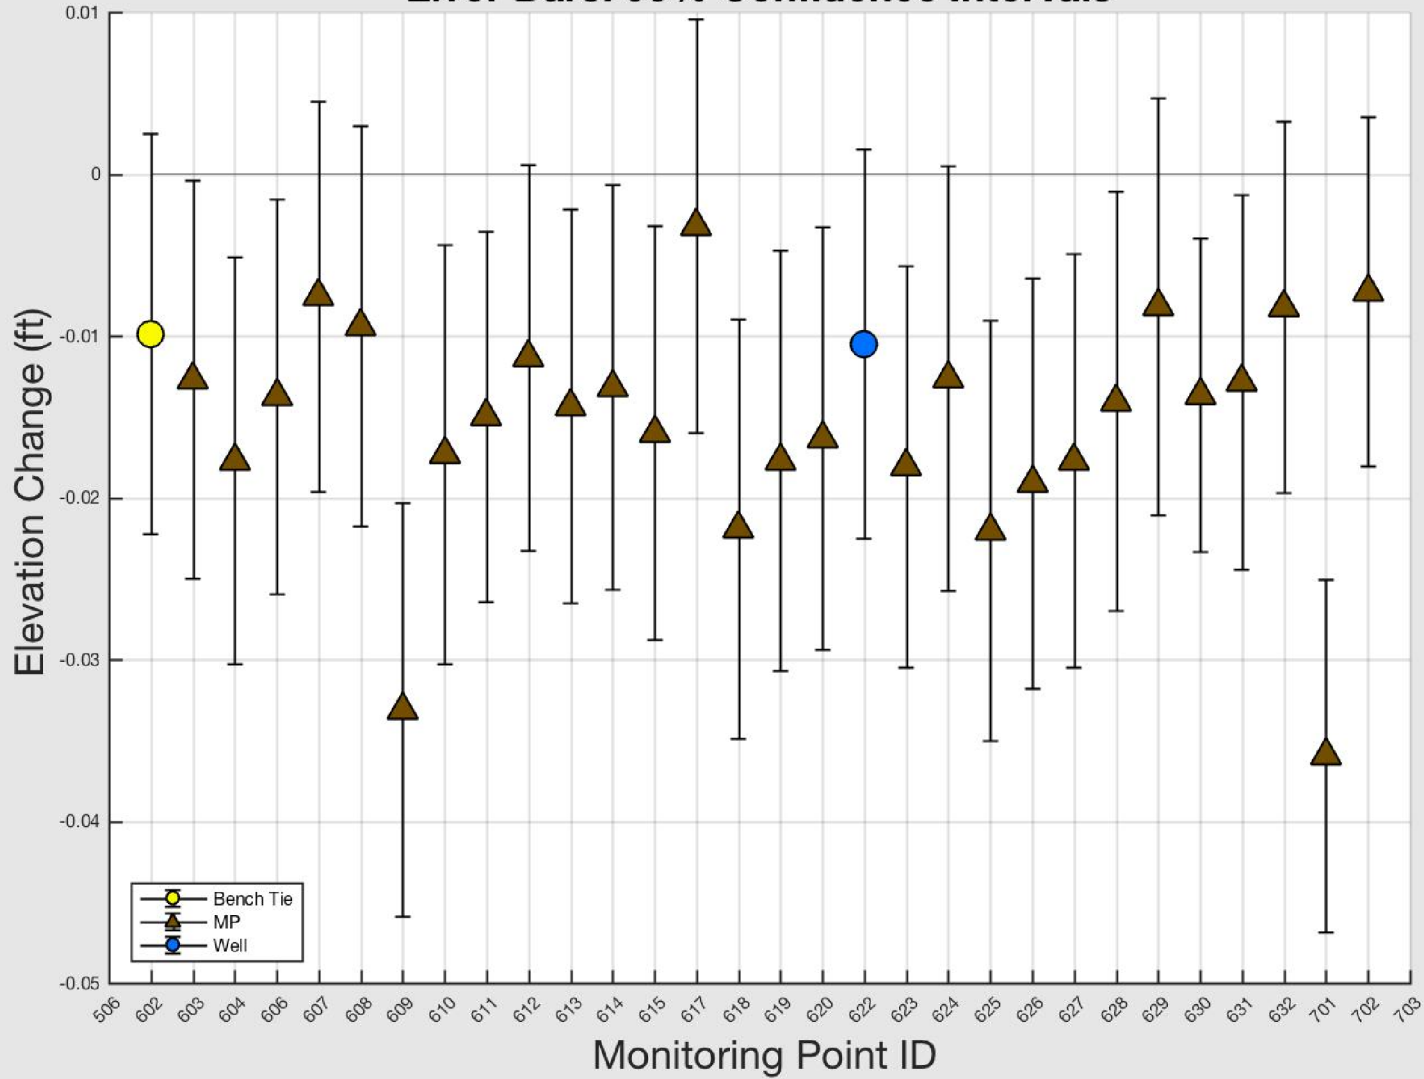
2 OF 4

FIGURE 2-9
RED LODGE SUBSIDENCE
MONITORING INVESTIGATION
ELEVATION CHANGES
QM9 THROUGH QM12

Red Lodge Subsidence Survey

Elevation Change From QM10 through QM12

Error Bars: 95% Confidence Intervals

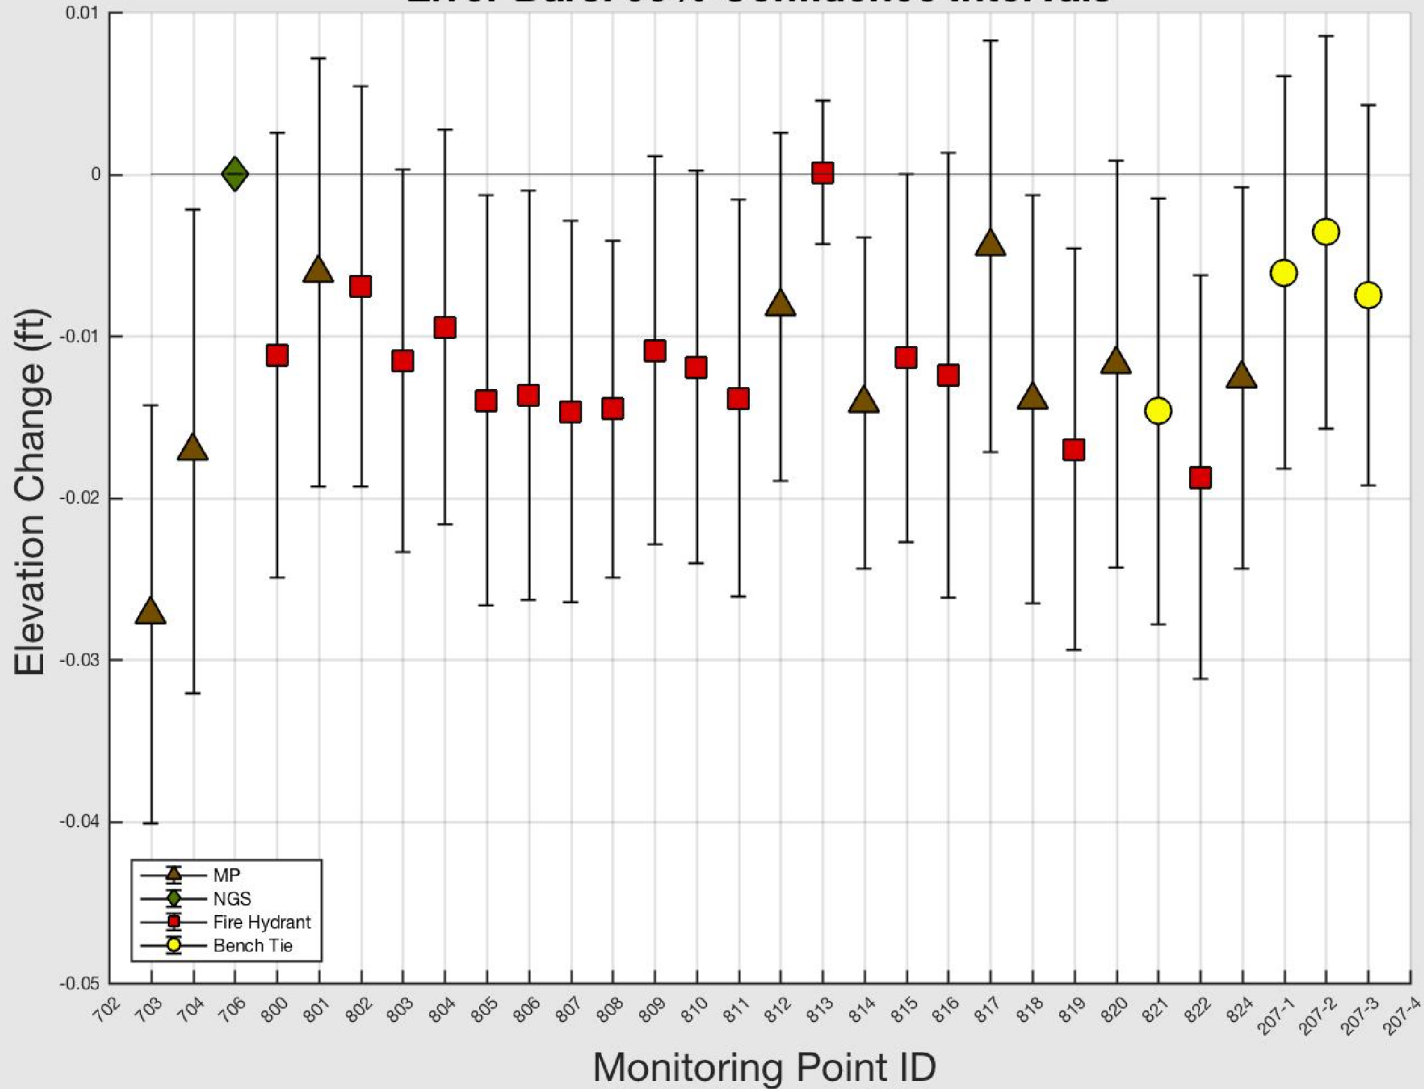
3 OF 4

RED LODGE SUBSIDENCE
MONITORING INVESTIGATION
ELEVATION CHANGES
QM9 THROUGH QM12

**Red Lodge Subsidence Survey
Elevation Change From QM10 through QM12
Error Bars: 95% Confidence Intervals**

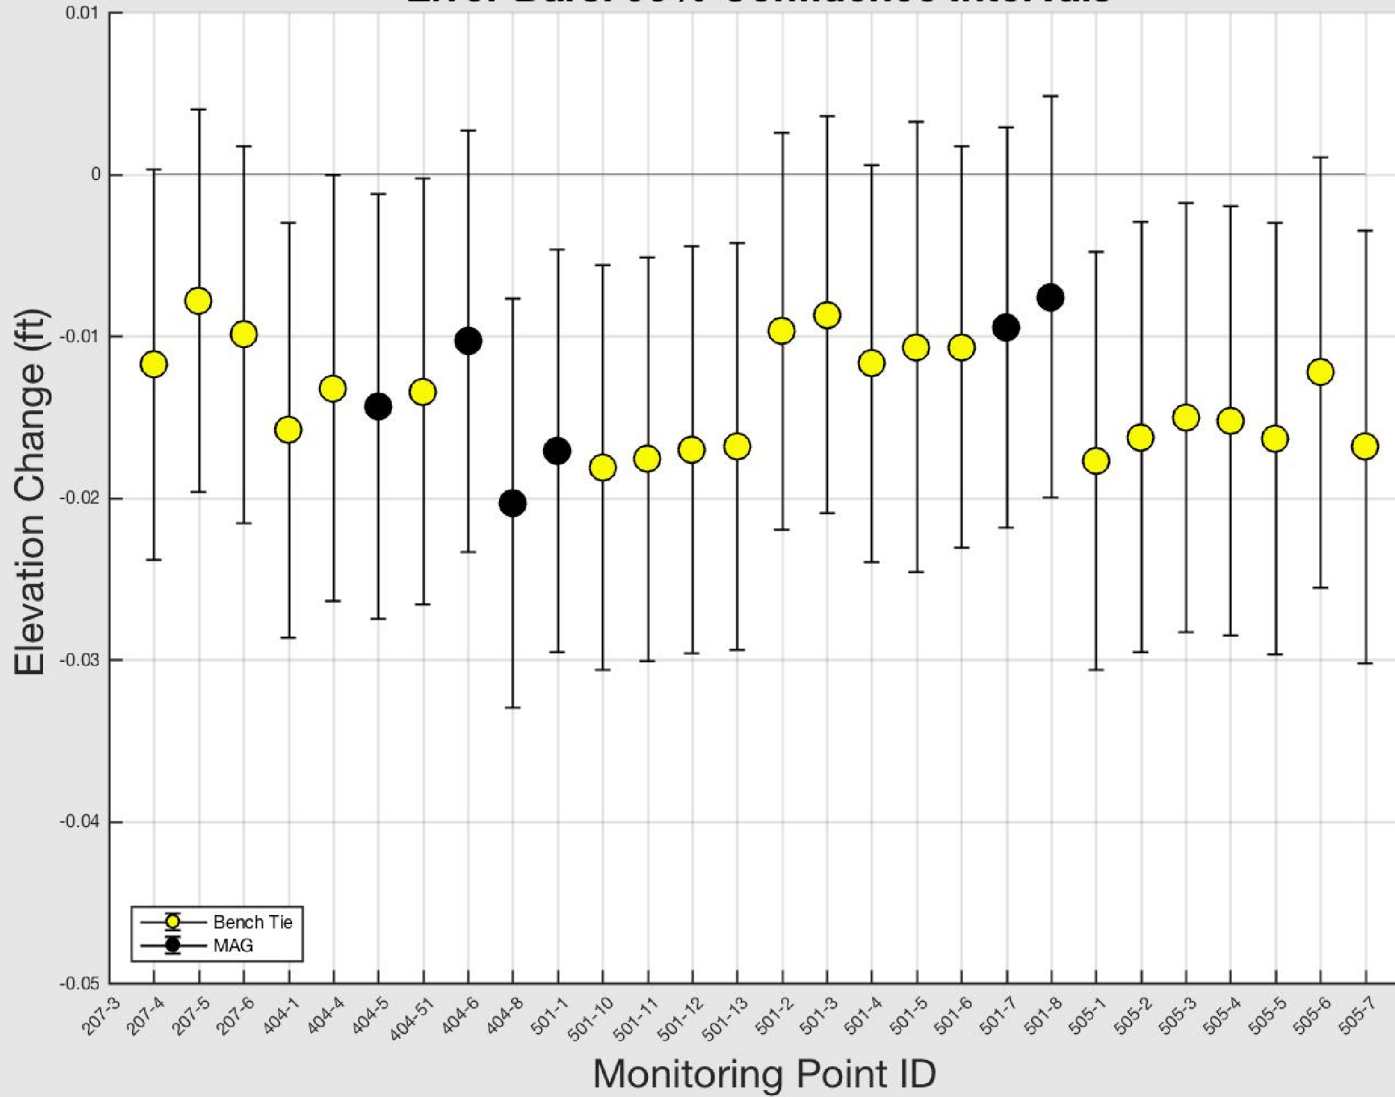
4 OF 4

**RED LODGE SUBSIDENCE
MONITORING INVESTIGATION
ELEVATION CHANGES
QM9 THROUGH QM12**

Red Lodge Subsidence Survey Frequency of Elevation Change Measurements

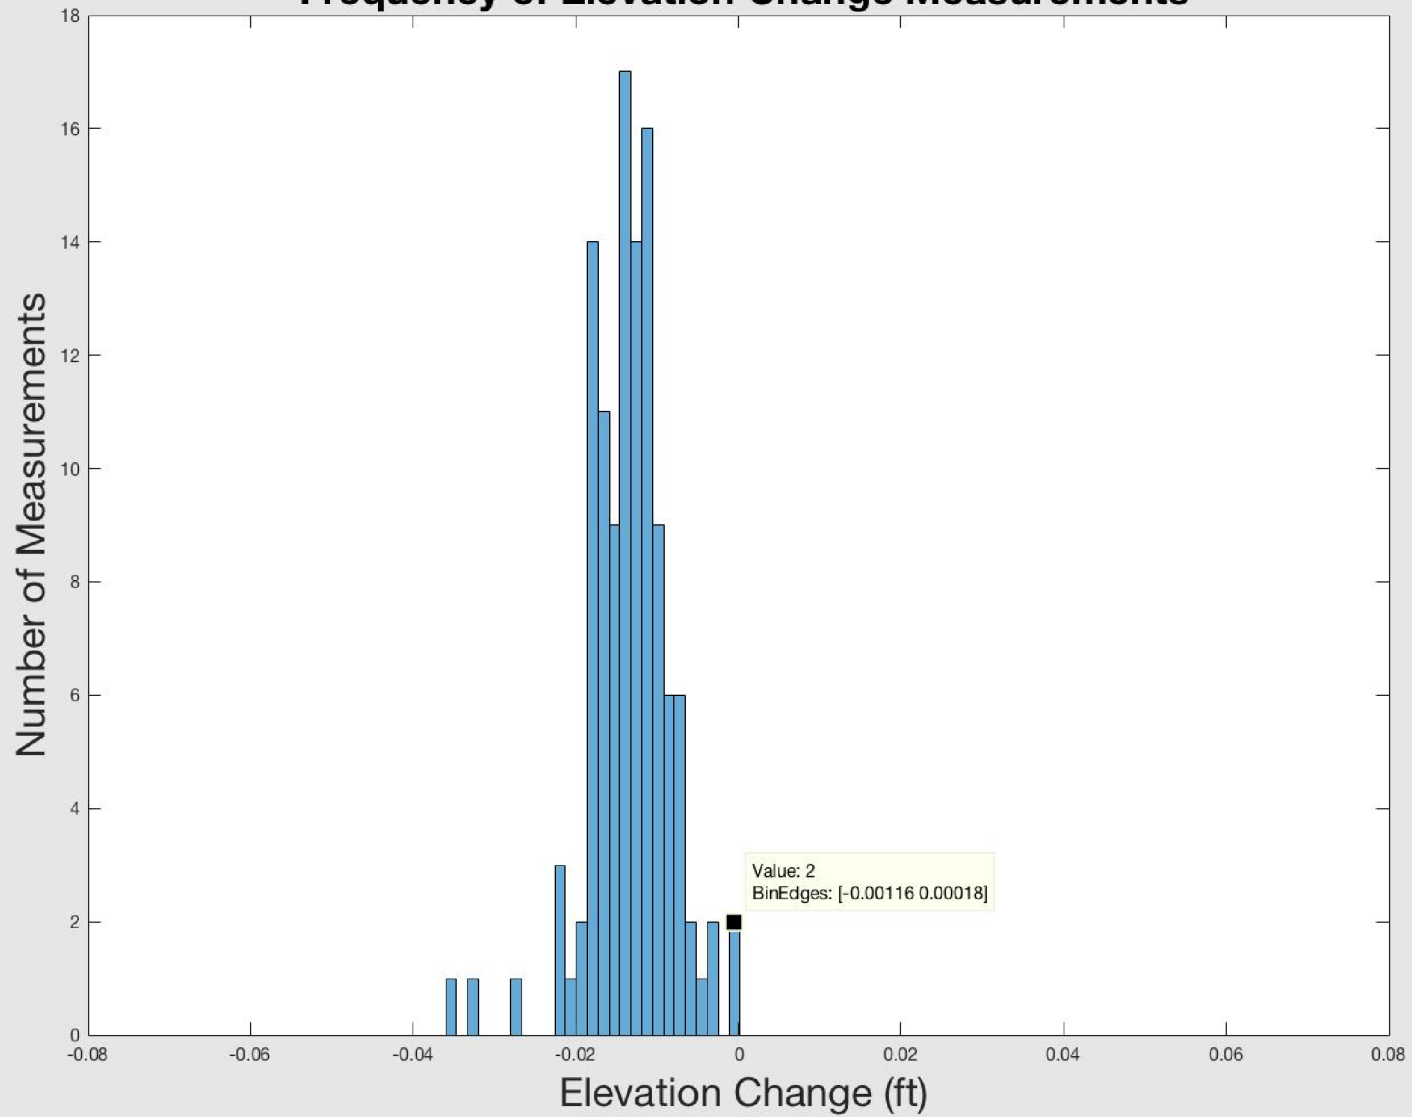
FIGURE 2-12

**RED LODGE SUBSIDENCE
 MONITORING INVESTIGATION
 DISTRIBUTION OF ELEVATION
 CHANGE MEASUREMENTS**

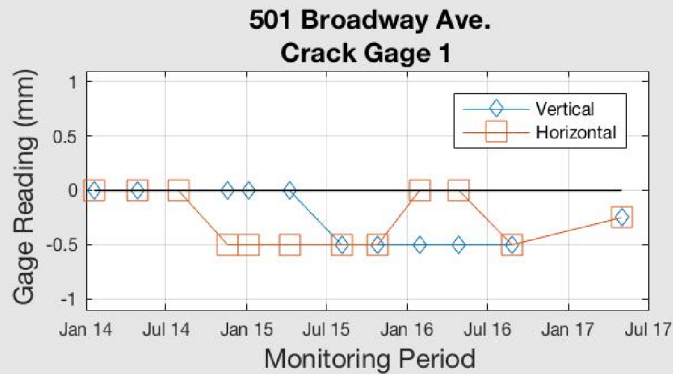
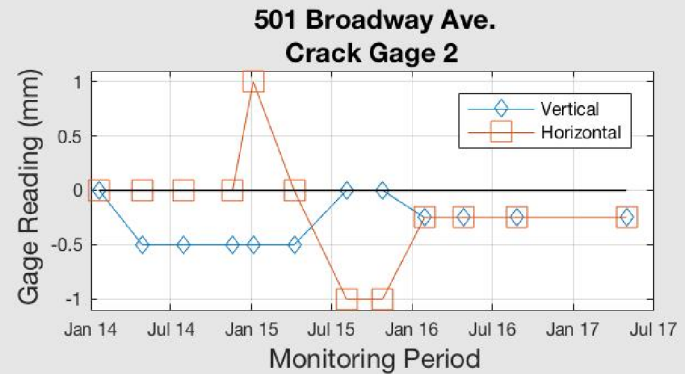
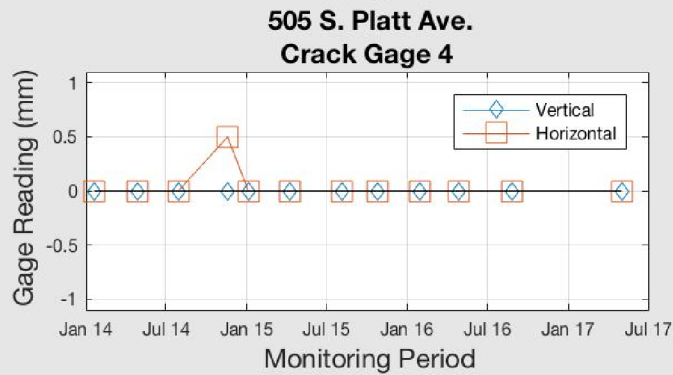
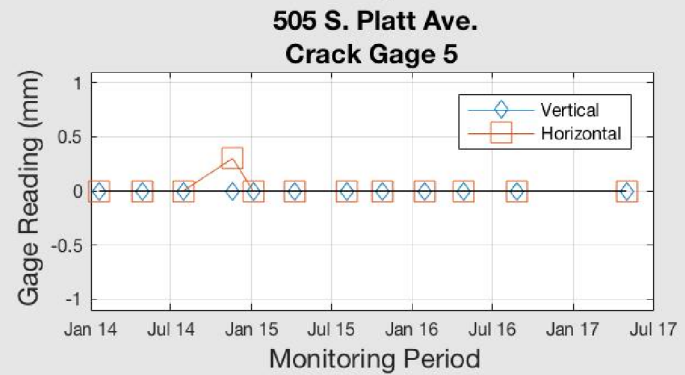
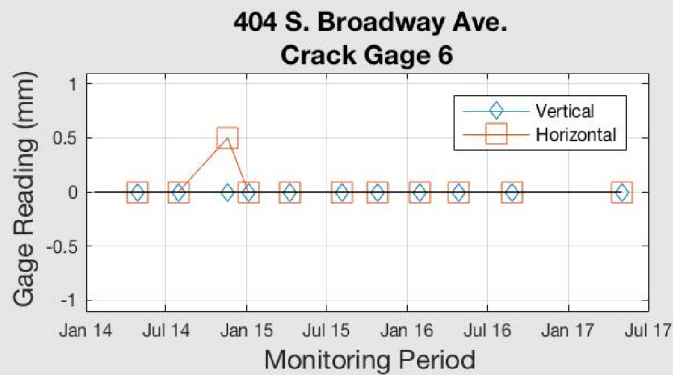
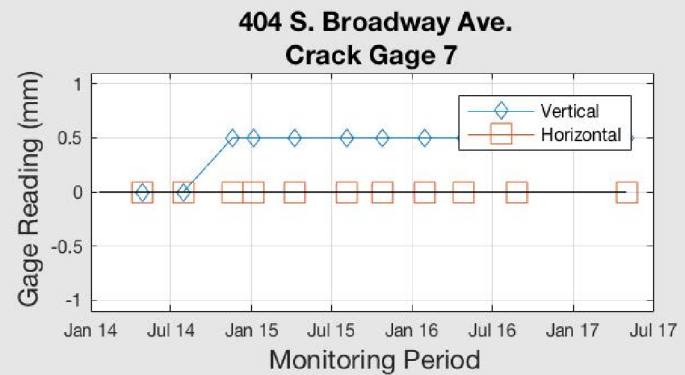
READINGS SHOW RELATIVE
MOVEMENT BETWEEN POINTS A
AND B (EITHER SIDE OF CRACK)

FIGURE 3-1
RED LODGE SUBSIDENCE
MONITORING INVESTIGATION
CRACK GAGE MEASUREMENTS
DATE: 10/12/2017
